Lakeside Village Condominiums

Lakeside Village
Federal Way, WA

RESERVE STUDY

Update "With-Site-Visit"

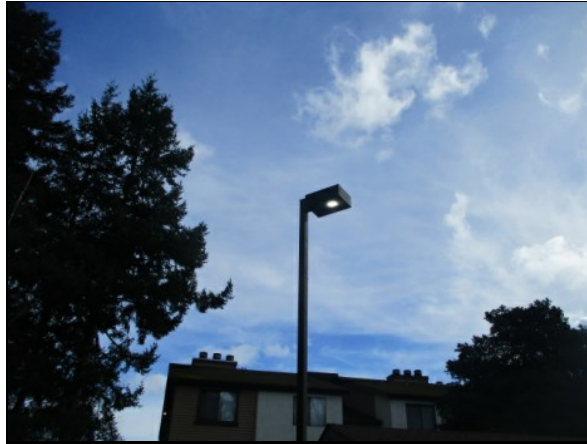
Durable metal construction but anticipate eventual large scale replacement to maintain uniform functionality and safety.

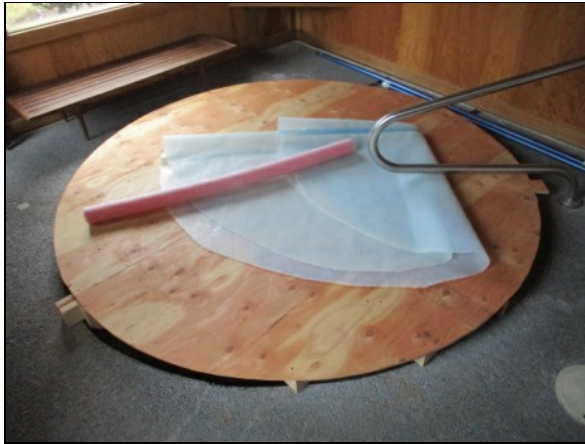
Comments: Spa was covered at time of inspection. This component represents future intervals of regular plaster resurfacing and tile work. Expect to schedule more frequently compared to pool due to chemical concentrations and higher heat.

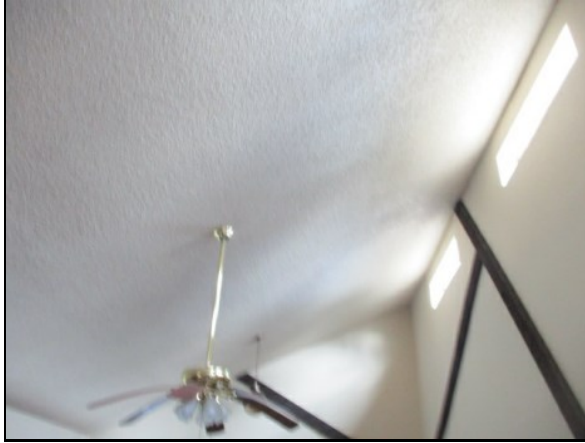
Comments: Interior surfaces had consistent paint coverage but signs of age were visible. Regular cycles of painting and refinishing of wood and drywall surfaces (including spa room) are recommended to maintain appearance.

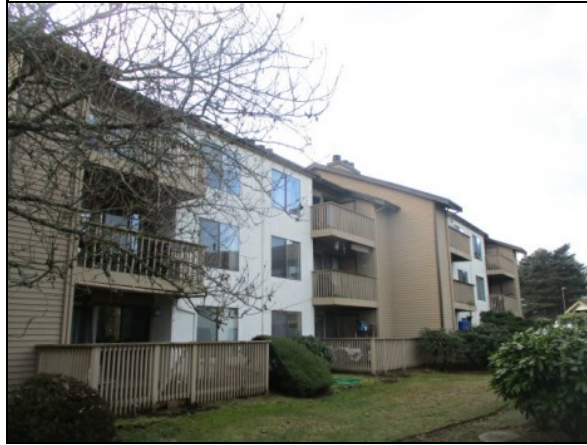
Comments: This component represents Phase 2 of 3 and includes Buildings 1, 2 and Carports. For full painting details see component #532 above.

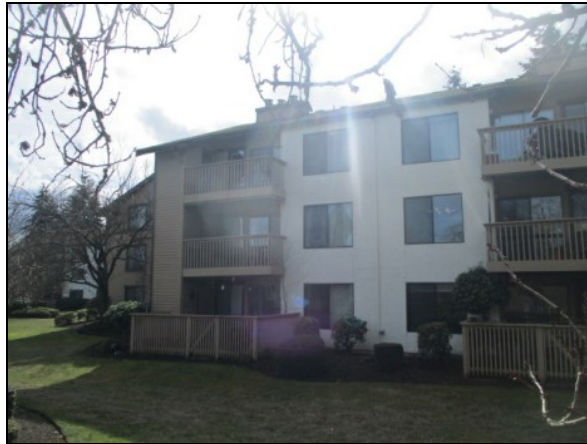
Comments: This component represents Phase 3 of 3 and includes Building 3 and includes mailbox kiosks, lamp posts, bridge, storage sheds, garbage enclosures. For full painting details see component #532 above.
