## Update "With-Site-Visit" Reserve Study

### Lakeside Village Federal Way, WA

**Report #: 13297-8**  
**For Period Beginning: January 1, 2018**  
**Expires: December 31, 2018**

**Date Prepared: February 28, 2017**

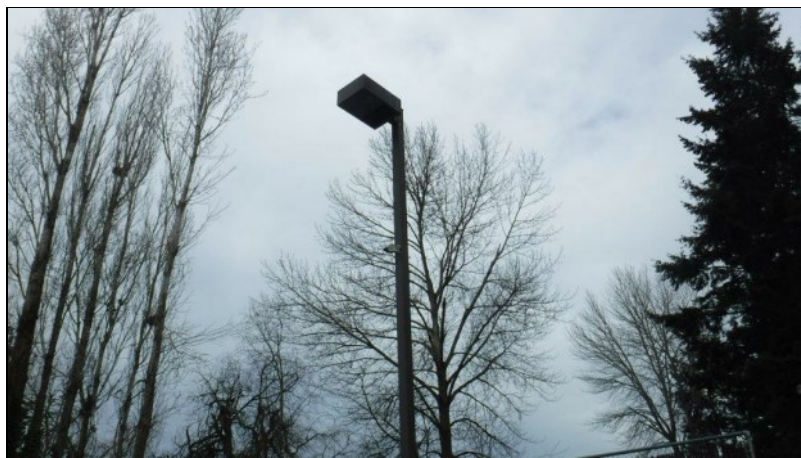
Evaluation: Fair condition with no advanced deterioration. Same maintenance recommendations as with smaller pole lights will apply here as well. Durable metal construction but anticipate eventual large scale replacement to maintain uniform functionality and safety.

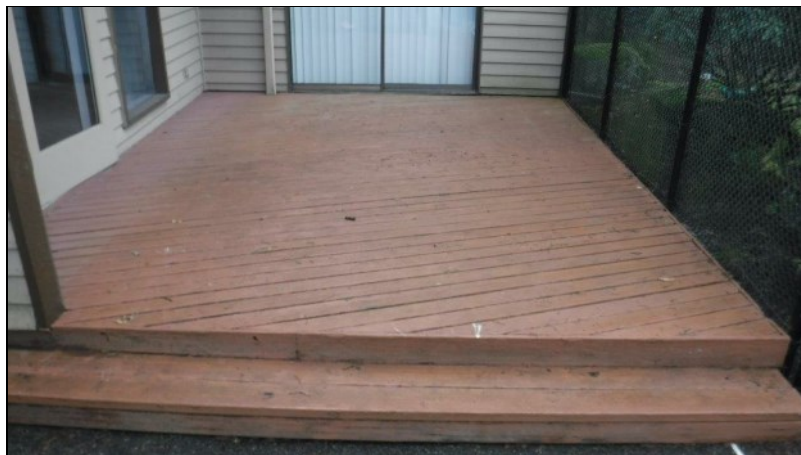
Evaluation: Fair structural condition but appearance of surface finish is poor and overdue for maintenance. As operating expense, regularly clean and apply sealer/stain/paint for protection, appearance and maximum design life. Select appropriate traffic coating product specifically for wood decks. Plan for significant repair/replacement at roughly the time frame below.

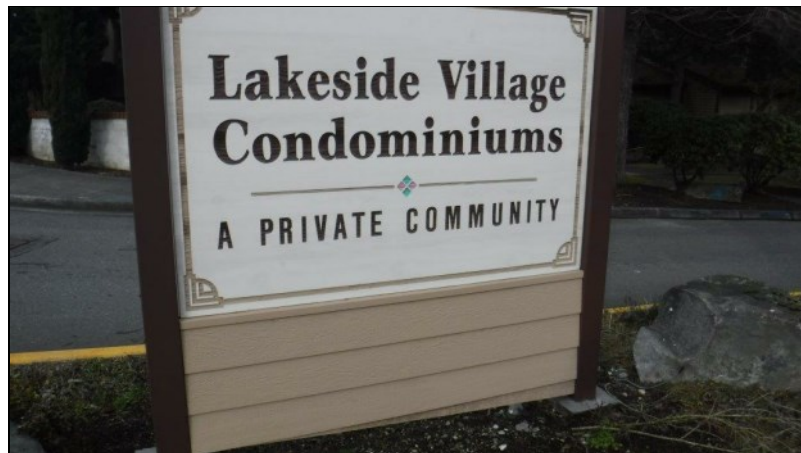
Evaluation: Good condition of newly replaced double-sided entry sign. Inspect regularly, clean grime and organic matter from sign to prolong useful life.

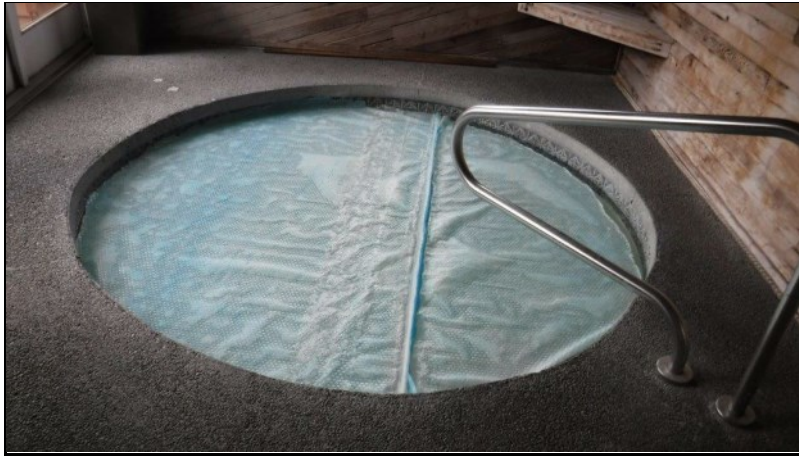
Evaluation: No deterioration, fading, staining or wear of plaster was noted. Code compliance and repairs at a one-time project expense of \$18,000 were completed in 2014. This component represents future intervals of regular plaster resurfacing and tile work. Expect to schedule more frequently compared to pool due to chemical concentrations and higher heat.

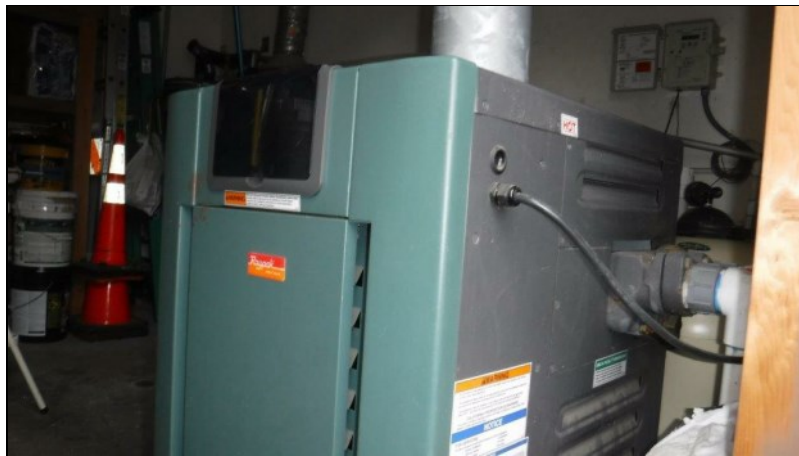
Evaluation: New 200,000 BTU input unit, replaced last in 2014. Segregated cost was not provided. Plan for regular intervals of replacement at roughly the time frame listed below.

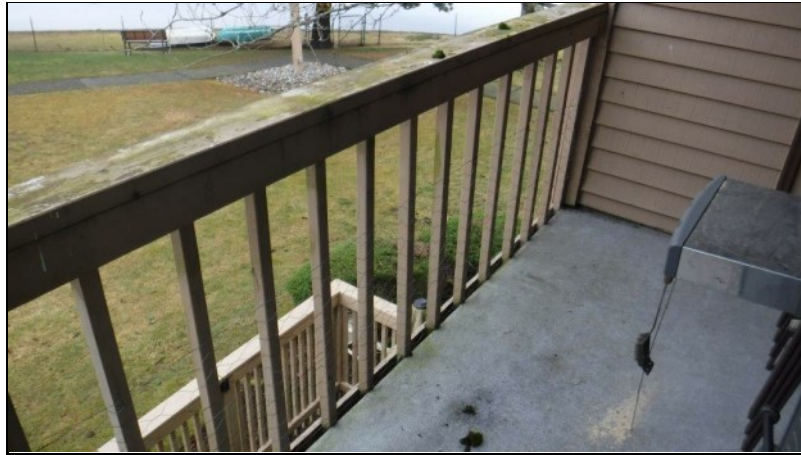
Evaluation: Last of six phases, represents future cycles of deck resurfacing and minor repair at those decks completed last in 2011 (424, 521, 522, 523, 524, 525, 526, 532, 533, 534, 535, 536). Note; photo is representative and not necessarily indicative of phasing.

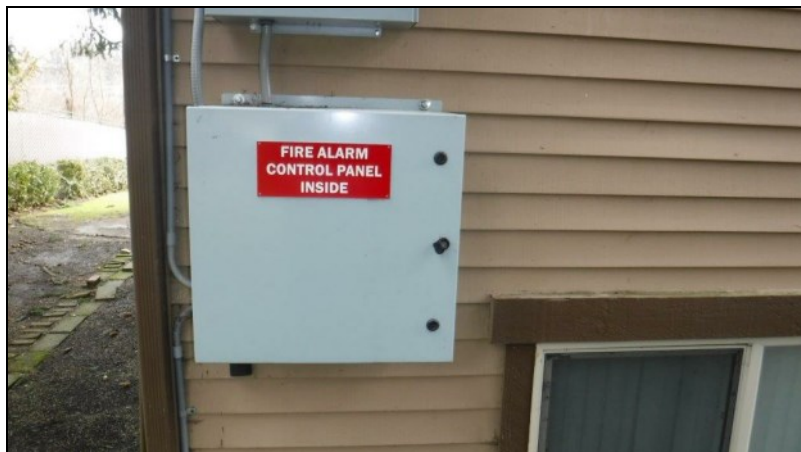
Evaluation: Unable to view actual fire panel during 2017 inspection. Fire monitoring and detection systems were installed in 2013; one-time project included electrical improvements. Going forward, individual owners are presumed to be responsible to maintain systems inside their respective units. Prudent planning includes setting aside funding for periodic replacement of fire panels at the roughly the interval indicated below.
