Client: 13297A Lakeside Village

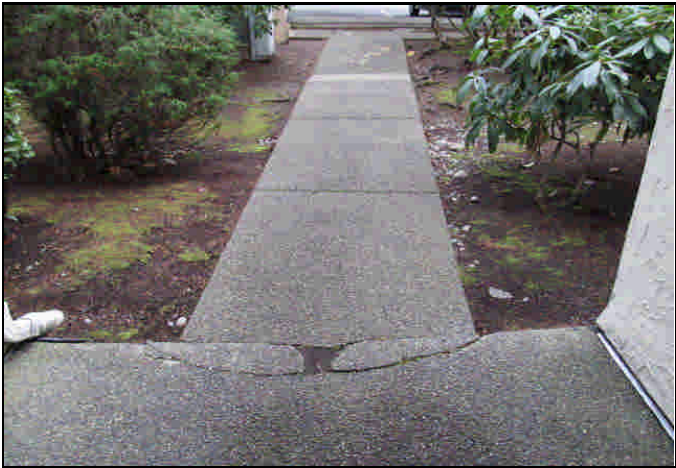
Comp #: 102 Concrete/Curb - Repair/Replace

Evaluation: Generally stable but local areas of damage, deterioration and upheaval were observed. Repair any trip and fall hazards immediately to ensure safety. Spot concrete and curb repair (shaving or replacement) has taken place in recent years and this practice is likely to continue. Association's repair needs should be evaluated at least annually and provided from general maintenance funds, not as a cyclical reserve component

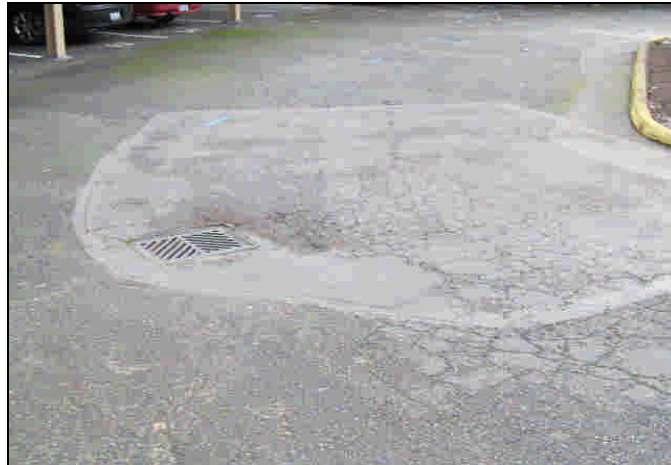
Comp #: 104 Asphalt - Seal/Repair

Evaluation: Fair to poor surface appearance with general deterioration, fading and previous repair illustrated. Local areas where alligating (cracking) and damage were apparent. Last significant maintenance project (targeted remove and replace along with seal coating of all asphalt reportedly occurred in 2008 at an expense of ~\$21,000.

Regular cycles of seal coating along with any needed repair has proven to be best program in our opinion for long term care of asphalt. Seal coating protects against damaging weather elements while bridging small surface cracks and providing uniform appearance over the inevitable patching and repairs needed over time. Use two coats of quality asphalt emulsion. Thorough surface preparation is also key to lasting job. Incorporate any curb paint into this project.

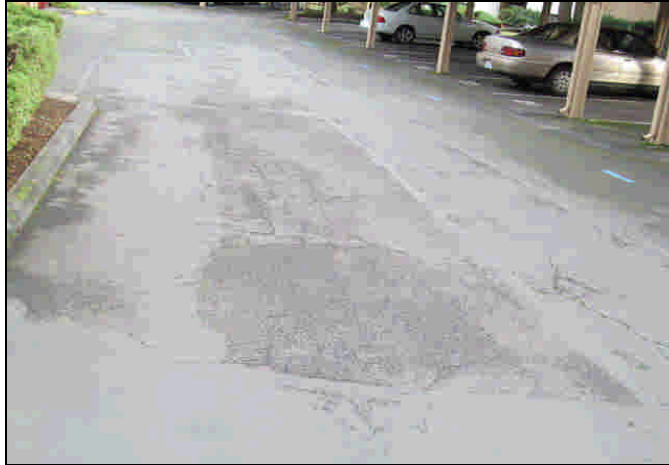
Comp #: 106 Asphalt - Resurface

Evaluation: General aging but no widespread damage or instability evident. As routine maintenance, keep surface clean and free of debris, ensure that drains are free flowing, repair cracks and clean oil stains promptly. Assuming timely maintenance occurs, anticipate eventual resurface (grind, overlay) at roughly the time frame below.

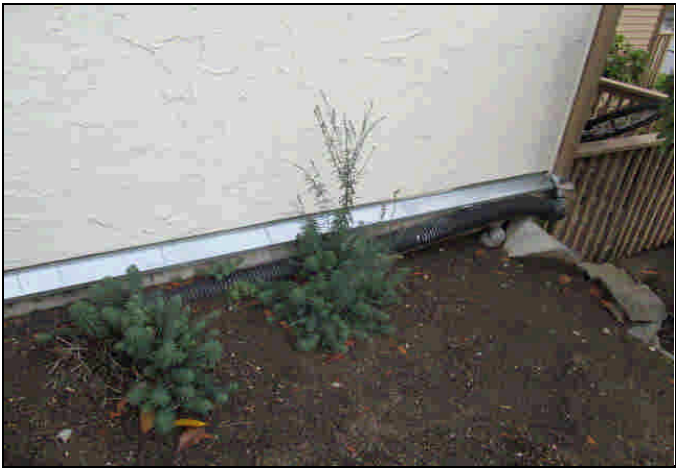
Comp #: 110 Drainage/Storm System - Replace

Evaluation: Systems include those within driveway/parking areas and yard drainage adjacent to buildings. Local drainage improvement projects have taken place in recent years with a \$10,670 expenditure in 2011. Inspect regularly, keep drains and grates free of debris and free flowing to ensure water evacuating as designed. Pump out sediments if needed utilizing mobile evacuator service. No further large scale projects are anticipated so ongoing maintenance and minor repair from general funds is assumed going forward.

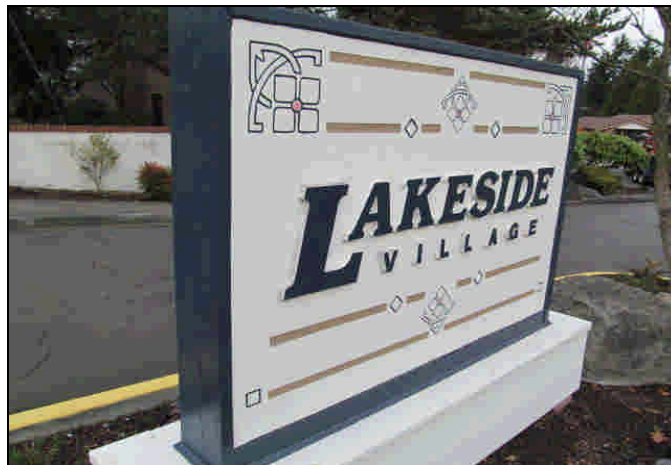
Evaluation: Good condition of double-sided entry sign. Refurbishing project by community volunteers was indicated in 2011; such small expenses (less than \$3,000) don't merit reserve designation.

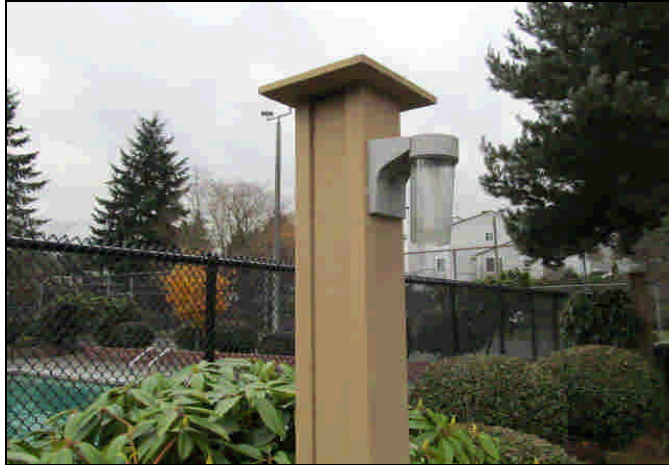
Comp #: 122 Wood Pole Lights - Replace

Evaluation: Half of total number were replaced in 2011 at an expense of only \$2,400; we assume partial replacements from operating budget will continue under this pattern of care. As routine maintenance, inspect and repair/change bulbs as needed. Paint along with building exterior surfaces or from operating budget.

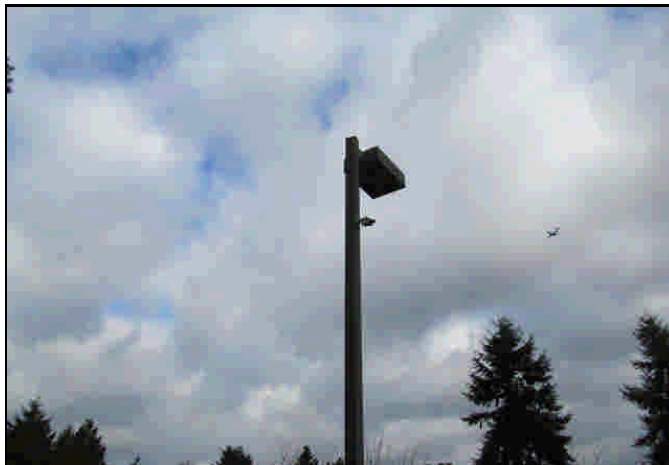
Comp #: 124 Metal Pole Lights - Replace

Evaluation: Fair condition with no advanced deterioration. Same maintenance recommendations as with smaller wood pole lights will apply here as well. Durable metal construction but anticipate eventual large scale replacement to maintain uniform functionality and safety.

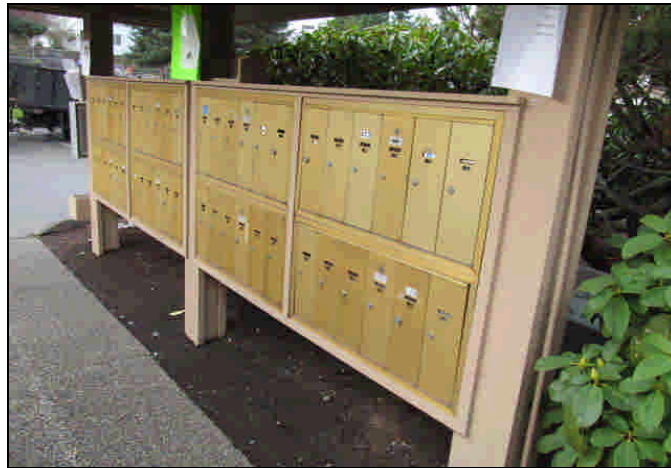
Comp #: 130 Mailboxes/Structures - Replace

Evaluation: Functional but general deterioration, surface pitting and worn appearance of metal mailboxes was observed. As before, eventual transition to cluster type mailboxes is likely in future (installed under existing mailbox shelters). Inspect regularly, clean by wiping down for appearance, change lock cylinders, lubricate hinges and repair as needed from operating budget. Maintain structures (roof, paint, repair) along with other exterior building surfaces; no need for separate funding. Plan for eventual replacement intervals of mailboxes (whether individual or cluster type), due to some exposure and constant usage and wear over time.

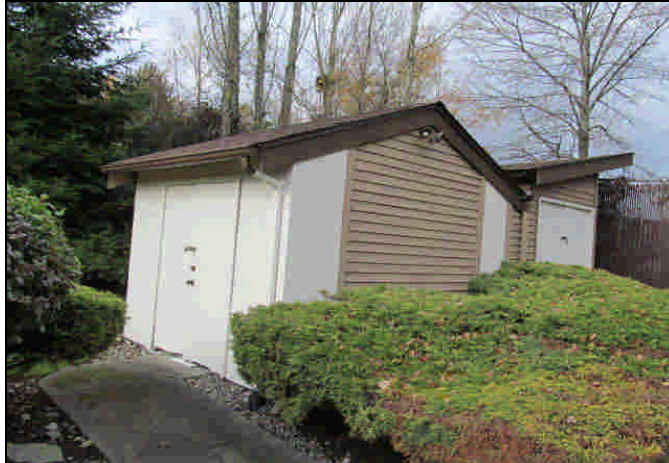
Comp #: 132 Storage Sheds - Maintain/Repair

Evaluation: Fair, stable condition. As with other small structures, maintenance and repair projects to coincide with larger residential buildings is assumed.

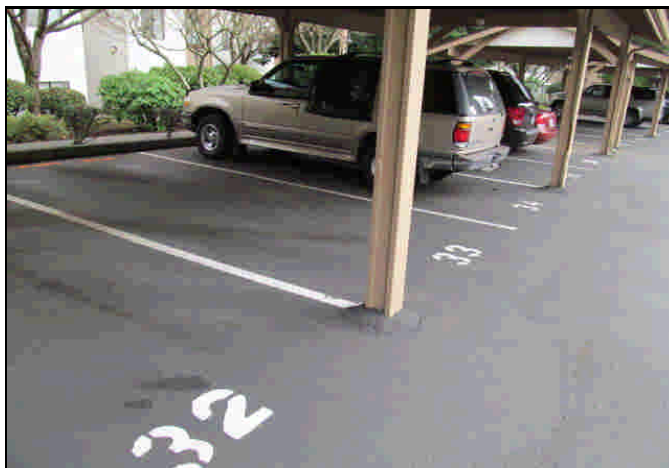
Comp #: 140 Carport Structures-Repair/Replace

Evaluation: Previous replacement of wood support posts in recent years was evident (with improvement to help shed water away from bases more effectively). Going forward, we suggest inspecting structures regularly, repairing promptly as needed from operating budget to help avoid larger replacement needs. Clean, and paint along same cycles as other building structures, no need for separate funding. Roof replacement/expenses are found within Component # 608, Carport Roof - Replace. No anticipation of separate large scale repair needs concerning carport structures with ordinary care and maintenance. No reserve funding recommended.

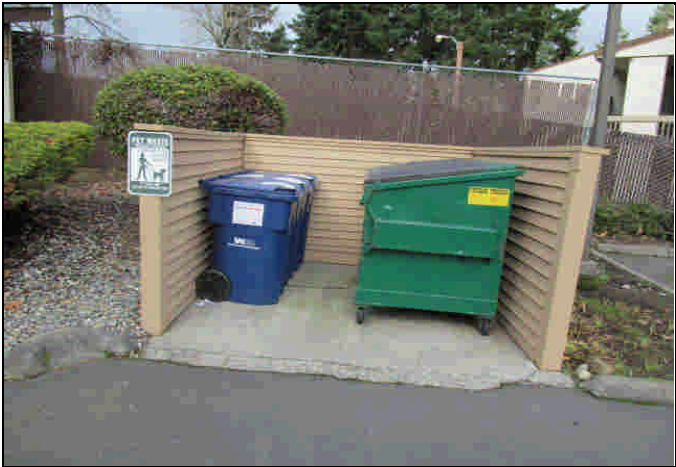
Comp #: 144 Garbage Enclosures-Maintain/Repair

Evaluation: Fair condition with no significant damage. These simple wood constructions without gates may continue to be sustained as needed from operating budget. Treat individual structural repairs/replacments as an ongoing maintenace item.

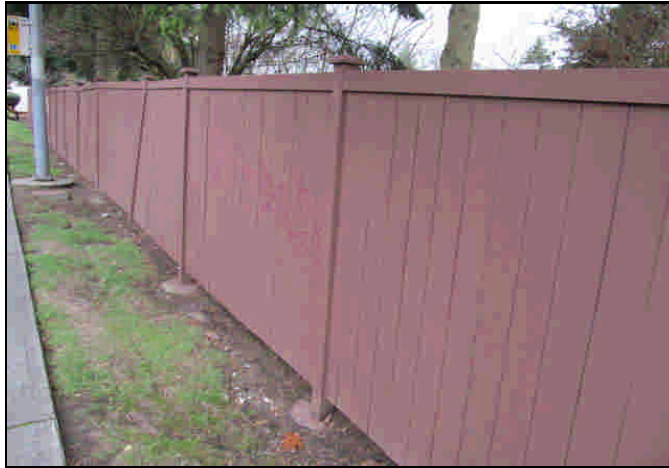
Comp #: 150 **Perimeter Fence, South-Replace Part**

Evaluation: Condition varies for wood fencing upon South perimeter but mostly fair and stable. No anticipation of all-at-once replacement as significant local renovations occur every few years to sustain as barrier and maintain aesthetics (~\$3,000 last in 2011). In any event, continue to avoid contact with ground and surrounding vegetation and provide regular intervals of refinishing to protect wood and help to maintain appearance (paint project expenses have occurred along with exterior buildings in recent years). Intervals of significant local replacements will likely continue going forward, next projected to occur in 2014. Track expenses and update in future reserve updates as conditions merit.

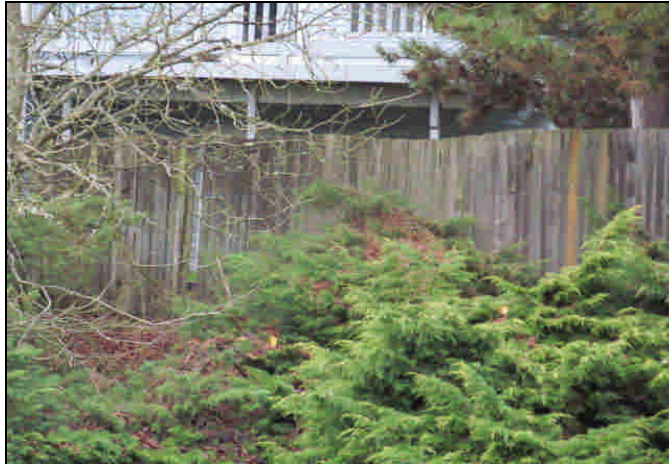
Comp #: 152 Perimeter Fence, West - Replace

Evaluation: Fair to poor condition with more deterioration observed at this wood fencing along perimeter adjacent to neighboring community (Birchwood). Association Manager indicated that any maintenance/replacement expenses of this run of wood fence would be shared equally with the neighboring community. Plans for replacement continue to be deferred but eventual large scale replacement is projected in the near future subject to the agreement of neighboring community.

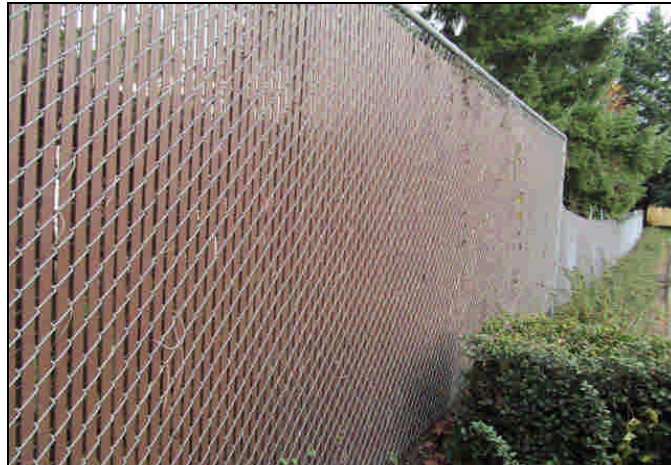
Comp #: 160 Perimeter Fence, North - Replace

Evaluation: Two different ages, condition, types and height of chain link fencing with slats lead us to conclude that these runs are likely owned by the two adjacent communities. No known shared maintenance agreements so no impact upon reserves is factored.

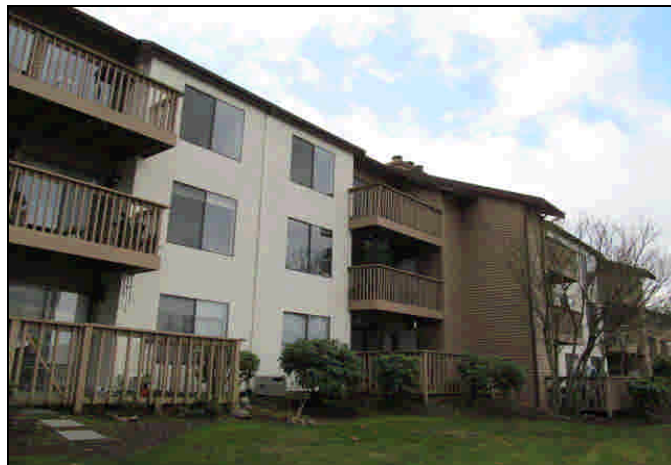
Comp #: 162 Building 3-5 Patio Fences - Replace

Evaluation: General deterioration with Management indicating plans for replacement of grade level patio fences at Buildings 3, 4 and 5 to occur in 2013 at a projected expense of \$27,200 (\$1,700 per yard). For purposes of general planning, assume similar large scale replacements expressed at the interval below. Time projects to coincide with paint cycles for cost efficiency if possible.

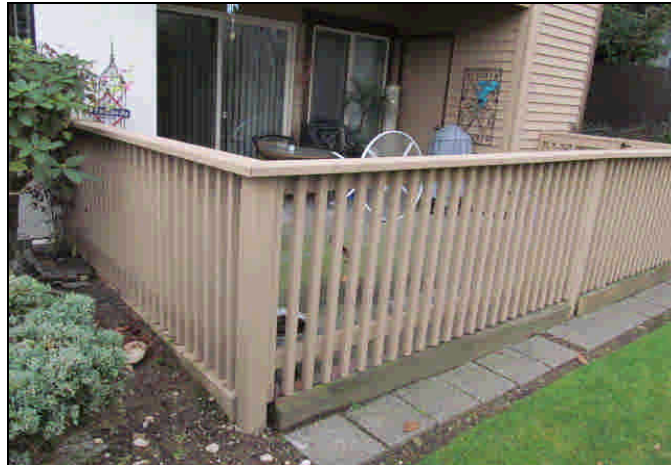
Comp #: 163 Building 1-2 Patio Fences - Replace

Evaluation: Good condition; repairs were completed in recent years with \$9,000 expenditure in 2011. Assuming proactive maintenance from general operating funds and timely paint intervals, anticipate next interval of significant replacement projected below.

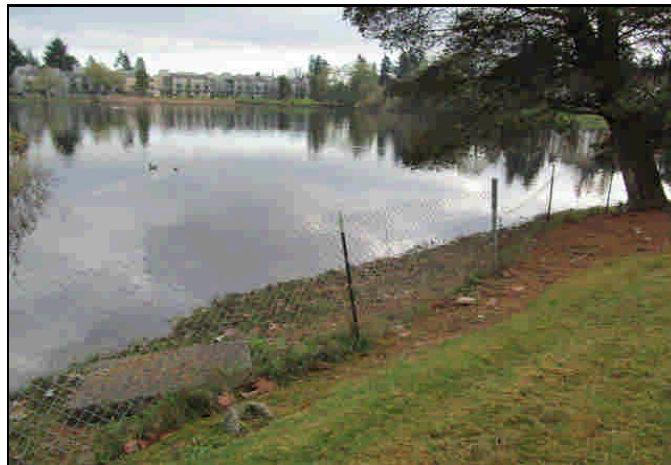
Comp #: 164 Goose Fence - Replace

Evaluation: Plans for replacement of existing wire fence, transitioning to a 3' vinyl coated chain link, have been deferred and are now indicated for 2013 at a preliminary expense of \$5,000. Reserve funding recommended at the level indicated below.

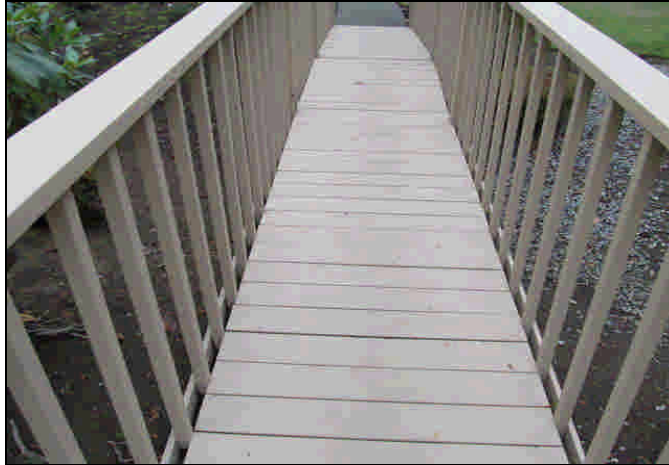
Comp #: 170 Wood Bridge - Repair/Replace

Evaluation: Fair condition without noteworthy deterioration. Inspect regularly, clean for appearance, paint and repair promptly as needed from operating budget. No reserve funding anticipated for large scale replacement if sufficient provision from annual operating budget is maintained.

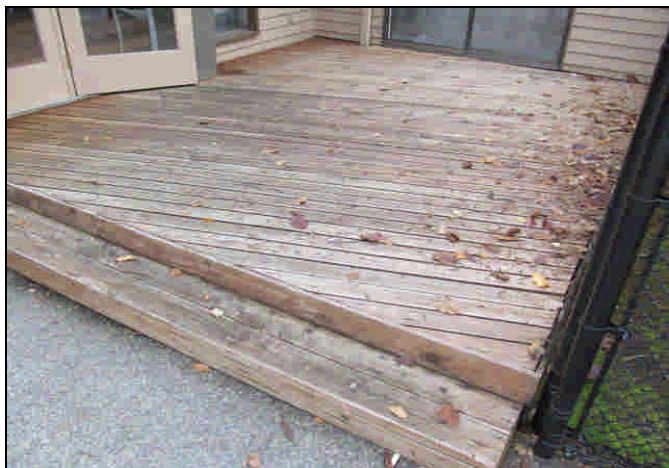
Comp #: 172 Cabana Deck - Repair/Replace

Evaluation: Good structural condition; refurbished last in 2008. Clean and apply sealer for protection, appearance and maximum design life. Plan for significant replacement at roughly the time frame below.

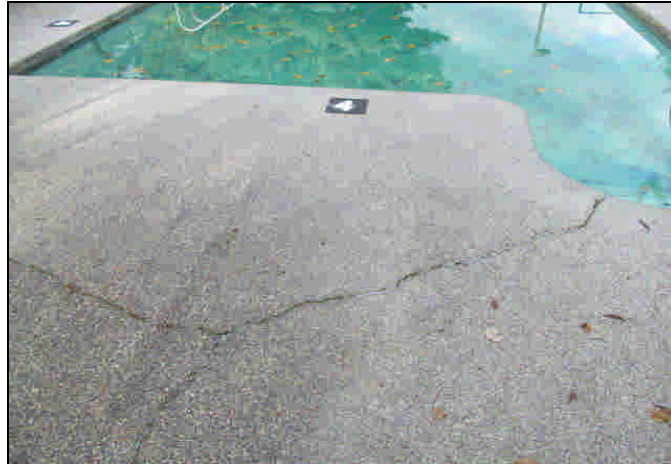
Evaluation: Local areas of surface cracking but no widespread instability noted. Inspect regularly, pressure wash for appearance, fill/seal any cracks which may develop to minimize further damage to pool deck and repair as needed from operating budget. There are a variety of ways to resurface pool decks, we recommend that research be conducted to evaluate the associations preferred method. Eventual removal and replacement with similar surface factored below.

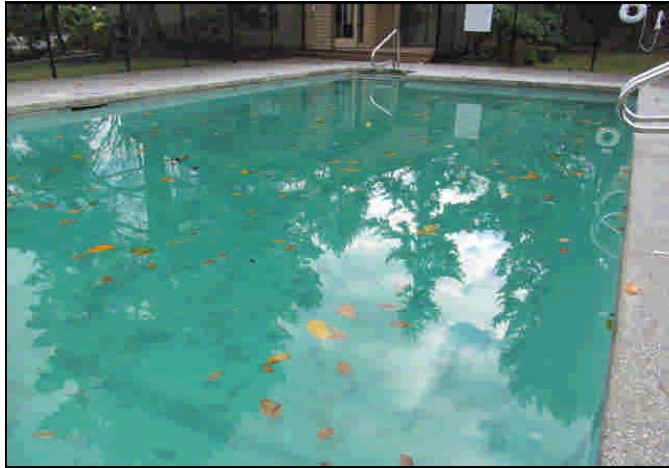
Evaluation: Similar poor condition with deterioration, fading and staining of plaster as our previous site inspection that occurred last in 2008. Tile work is also faded and has local damage. No plans or bids for resurface project to take place in 2012 as the community deals with higher priority issues. Project is long overdue and should occur as soon as possible in 2013. We recommend to continue to professionally clean and maintain as well as running the filters throughout the winter to minimize algae/debris buildup. Consider the purchase of a safety/winter cover to enhance security and reduce maintenance activity and expense. Best plan for regular intervals of pool resurfacing to maintain a quality appearance.

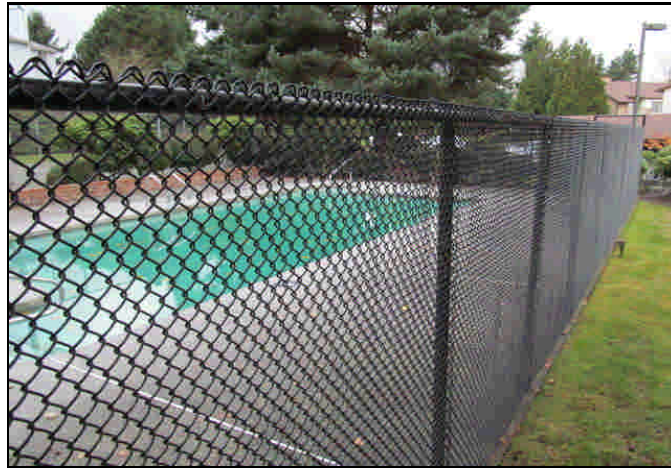
Comp #: 407 Pool Fence - Replace

Evaluation: Good condition of vinyl coated chain link fencing which was replaced last in 2008 at an expense of ~\$7,500 to comply with code requirements. Inspect regularly to ensure stability and repair as needed from operating funds; clean periodically to maintain good appearance. Highly visible location; plan for replacement at roughly the time frame below.

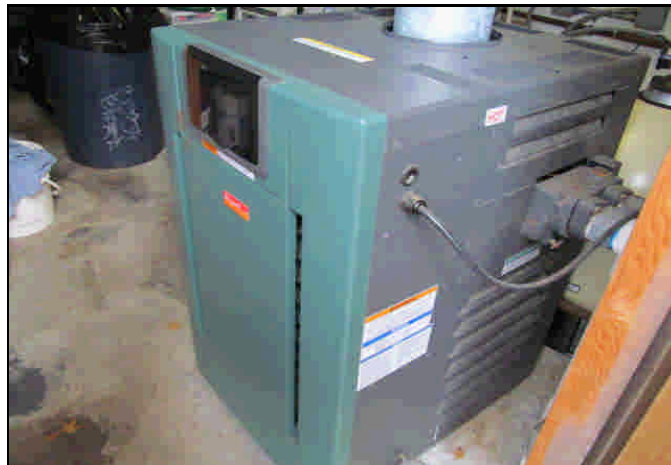
Comp #: 408 Pool Heater - Replace

Evaluation: Fair condition, replaced last in 2006. No reported or observed problems at this time. We recommend regular professional inspections, maintenance, and repairs to help maximize useful life cycles. Plan for regular intervals of replacement at roughly the time frame listed below.

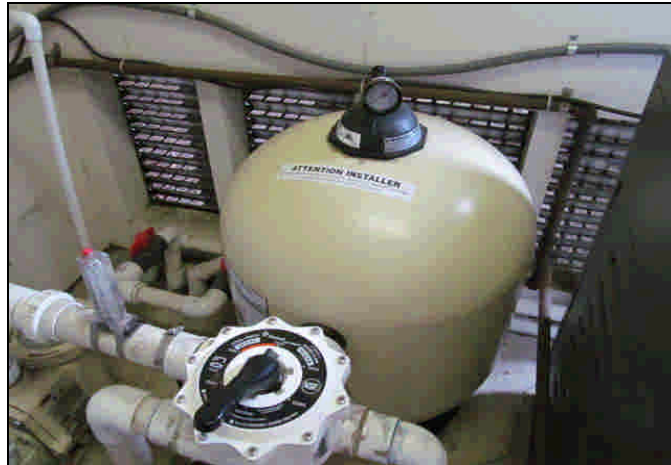
Comp #: 410 Pool/Spa Filters - Replace

Evaluation: Fair condition of pool media filter and spa cartridge filter with no reported problems. Varying ages, both replaced within the last 11 years. Inspect regularly, backwash, replace sand, cartridge and repair as needed. Too small an individual expense to merit reserve designation, continue treating as maintenance item.

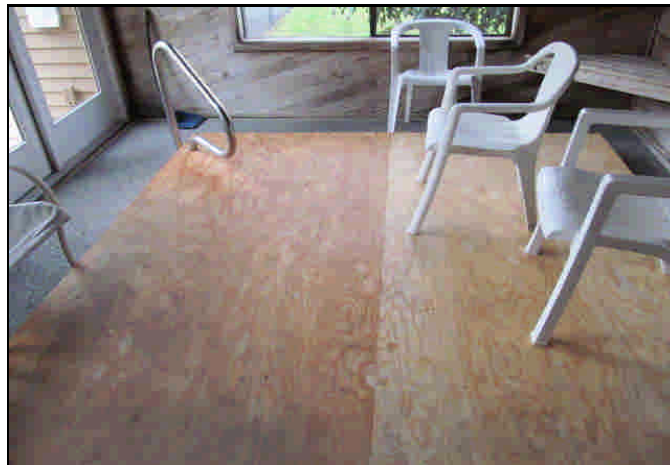
Evaluation: No direct observations were made since spa was covered up by plywood when we recently inspected. Decommissioned for a number of years but renovations are now planned in 2013. Code compliance and repairs at a one-time project expense of \$8,000 are projected below.

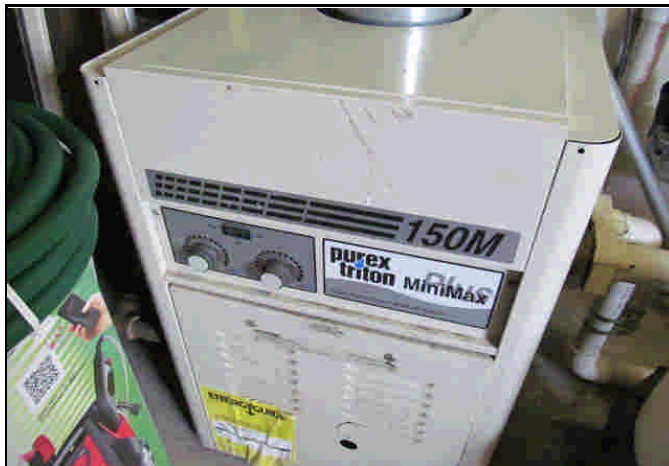
Comp #: 424 Spa Heater - Replace

Evaluation: Older 150,000 BTU input unit, replaced last in 2001 but since spa has been decommissioned for a number of years, useful life is likely extended. Plan for regular intervals of replacement at roughly the time frame listed below.

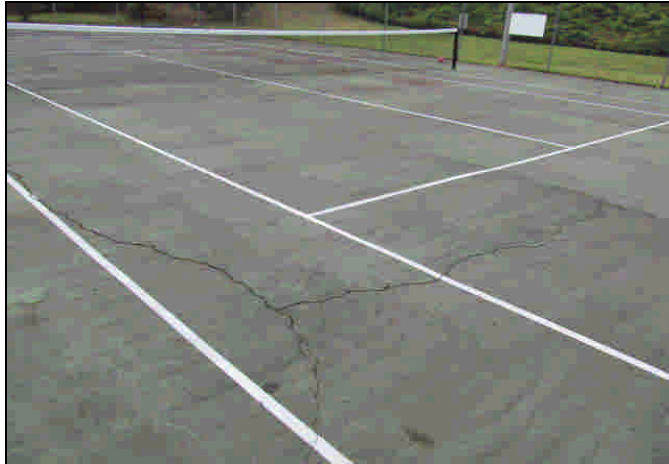
Evaluation: Fair to poor condition of asphalt surface with local cracking, damage and general deterioration observed. Inspect regularly, fill/seal any cracks which may develop to prevent further damage. No preliminary bids or plans for renovation to occur in 2012 or 2013 as the community deals with higher priority needs. For purposes of long term planning, large scale resurfacing (overlay) project to maintain this community amenity should be anticipated at the interval indicated below.

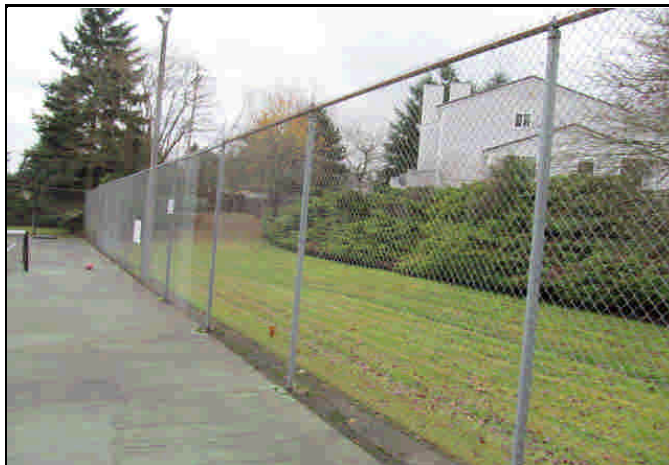
Comp #: 444 Tennis Court Fence - Replace

Evaluation: Some surface corrosion but no significant instability noted. Sturdy component that can last for extended period of time if not damaged or abused. Clean, treat for corrosion and repair as needed from operating funds. Best to plan for eventual replacement at the time frame indicated below.

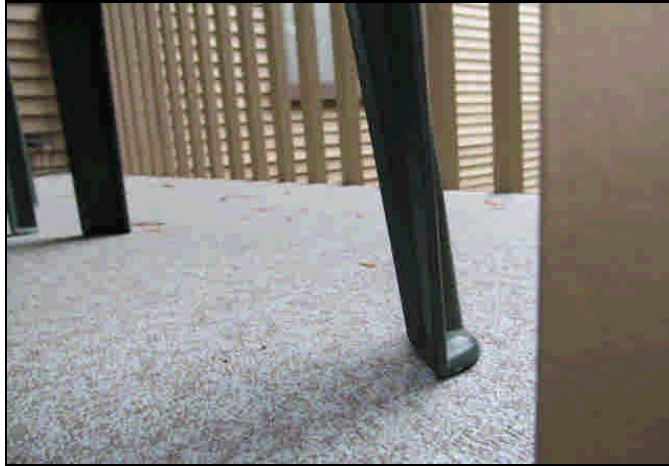
Comp #: 502 Vinyl Decks - Repair/Resurface (a)

Evaluation: Good to fair condition for the Association's (62) decks that utilize vinyl membranes for traffic surfaces. No problems with lifting or seam separation at the few decks we observed. Phased projects have occurred since 2006 to significantly repair deck structure, resurface and replace rails on a priority basis and are now completed. Vinyl traffic and water proofing material can typically last for extended period with ordinary care and maintenance. Take care when moving patio furniture, barbecuing, etc... not to gouge or damage. Annual professional inspections are strongly suggested to ensure waterproof integrity, proper adhesion of surface and drainage. Clean as needed with mild solution to prevent mildew. In our experience, covering will eventually fade and wear over time, necessitating regular intervals of replacement at roughly the 15-20 year time frame below. First of six phases, represents future cycles of deck resurfacing and minor repair at those decks completed last in 2006 (122, 124, 126, 132, 134, 136, 326). Note; photo is representative and not indicative of phasing.

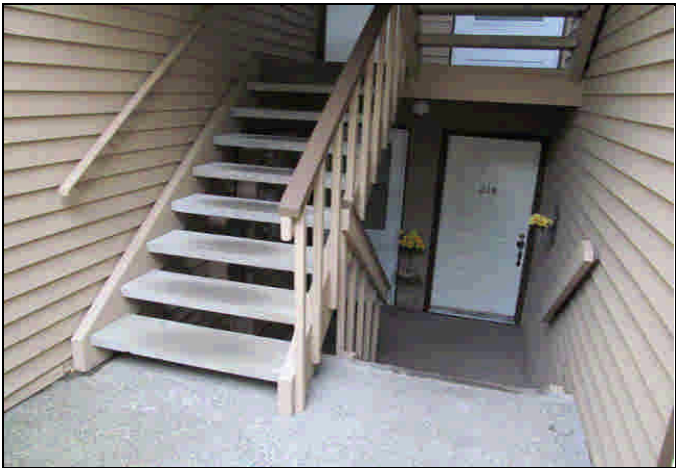
Evaluation: No widespread deterioration observed or significant prior repair history indicated. As routine maintenance, we recommend regular professional inspections to ensure stability and weather proofing; perform any needed repairs promptly. Ensure that tread connections are tight and secure. Paint components regularly along with building exteriors. Generally protected from exposure and utilizing concrete treads and landings with metal brackets for construction. With ordinary care and maintenance there is no anticipation of large scale expenses impacting reserves within the scope of this reserve study.

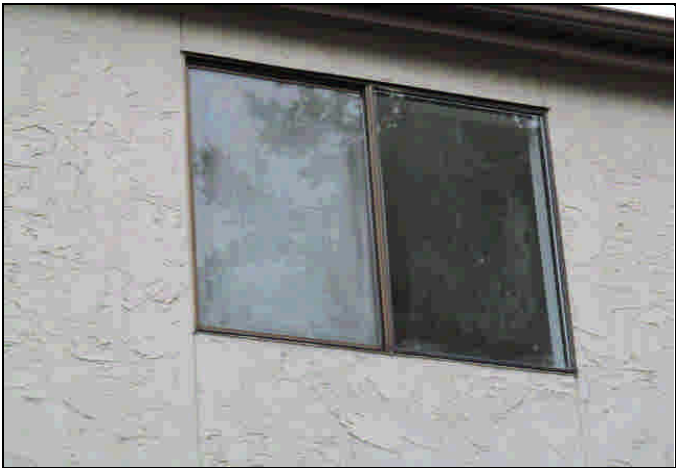
Evaluation: Varying ages, condition and types evident; many are older and some may even be original to 1980 construction. It is our understanding that replacement expenses for Unit windows/glass doors (glass and frames) are considered the responsibility of the respective Unit Owner. As with all exterior components that have an effect on weather proofing performance, regular inspections and maintenance, quality specifications and timely replacements are key regardless of responsibility for expenses. Regarding the few "common area" windows at the Cabana, we assume individual replacements when needed as an operating budget item.

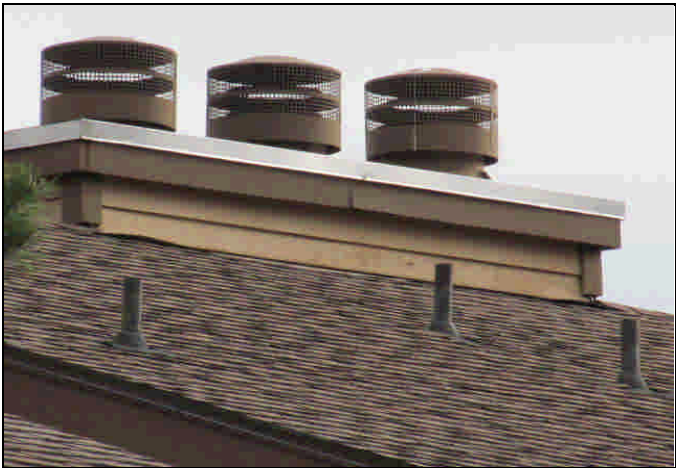
Evaluation: Some replacements in recent years were apparent, with Management indicating plans to continue replacing any remaining worn metal work as ongoing maintenance from operating funds (each cover/cap location at an expense of ~\$1,800 for stainless steel covers). Inspect regularly along with all rooftop components to ensure water proofing of buildings is maintained and clean/ treat with rust inhibitor where appropriate to help extend life. Assuming adequate provisions for timely replacements from annual budget we have not factored reserve funding. Track needs and expenses carefully if incorporating in future reserve study updates.
