Update “With Site-Visit” Reserve Study

Lakeside Village Federal Way, WA

Report #: 13297-5
For Period Beginning: February 1, 2015
Expires: December 31, 2015
Date Prepared: January 24, 2015

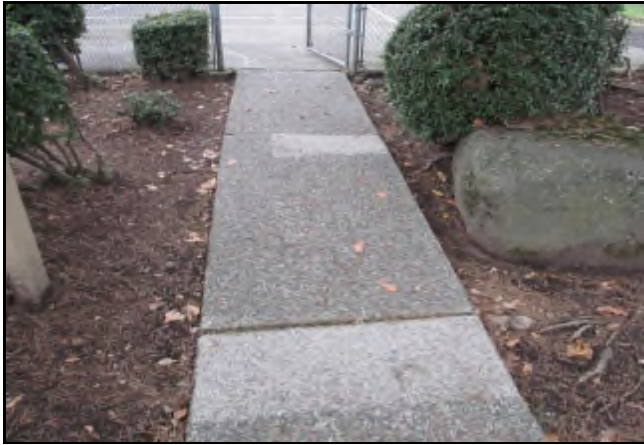
Comp # : 102 Concrete/Curb - Repair/Replace Quantity: Extensive square feet

History : \$14,500 repair expense in 2014, other previous spot repairs in recent years

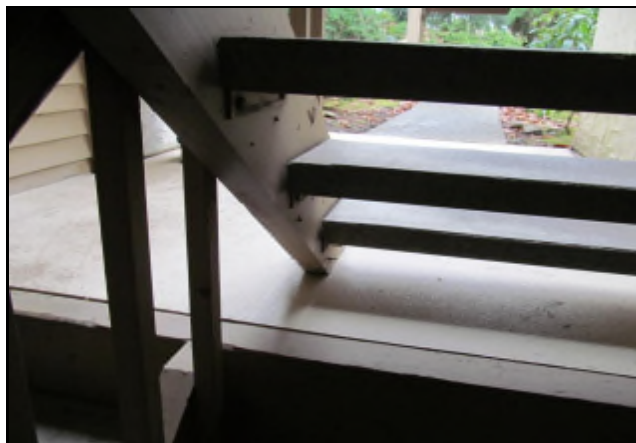
Evaluation : No widespread deterioration observed or significant prior repair history indicated for inset stairs or elevated landings. As routine maintenance, we recommend regular professional inspections to ensure stability and weather proofing; perform any needed repairs promptly. Ensure that tread connections are tight and secure. Paint components regularly along with building exteriors. Generally protected from direct exposure and utilizing concrete treads and landings with metal brackets for construction. With ordinary care and maintenance there is no anticipation of large scale expenses impacting reserves within the scope of this reserve study.
