## Update "With-Site-Visit" Reserve Study

### Lakeside Village Federal Way, WA

**Report #: 13297-11**  
**For Period Beginning: January 1, 2021**  
**Expires: December 31, 2021**

**Date Prepared: April 30, 2020**

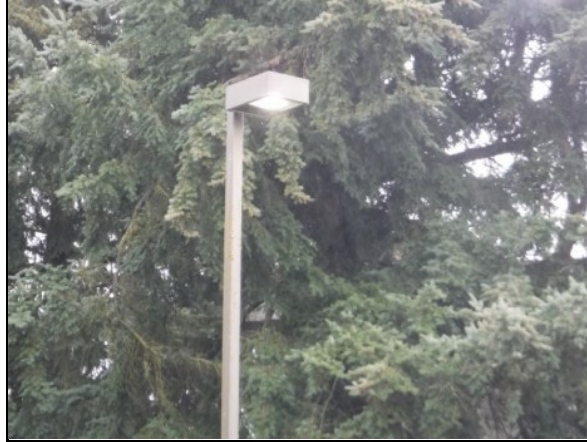
Durable metal construction but anticipate eventual large scale replacement to maintain uniform functionality and safety.

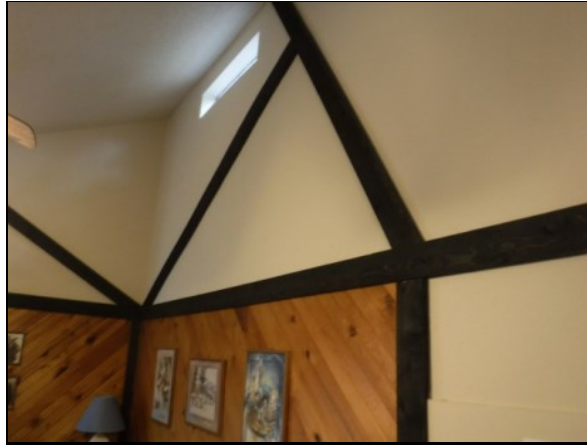
Comments: Majority of finishes in fair condition. Regular cycles of painting and refinishing of wood and drywall surfaces (including spa room) are recommended to maintain appearance.

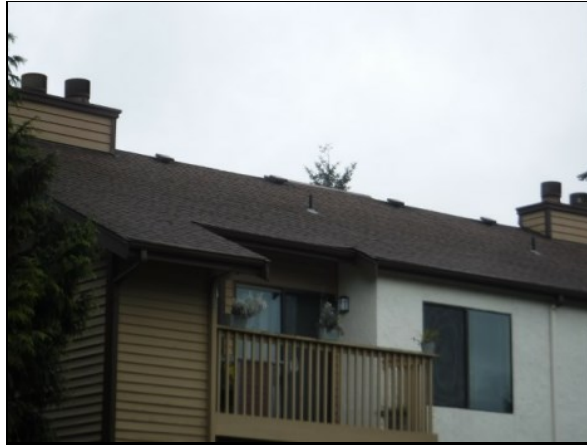
Comments: Fair, clean condition. Although warranty period may be longer, anticipate practical useful life of roughly 25 years as projected below. For complete details on roofing see component #500.

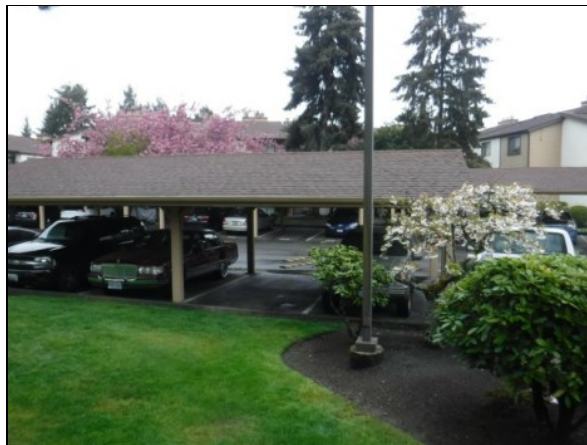
Comments: Generally fair condition with no excessive moss or observable damage. Carport roofs were replaced in projects that occurred in 2003, 2005 and 2008 . For purposes of long term planning, assume replacement of 2003 carport roofs as expressed below. Assume slightly lower per SF expense as compared to residential buildings.

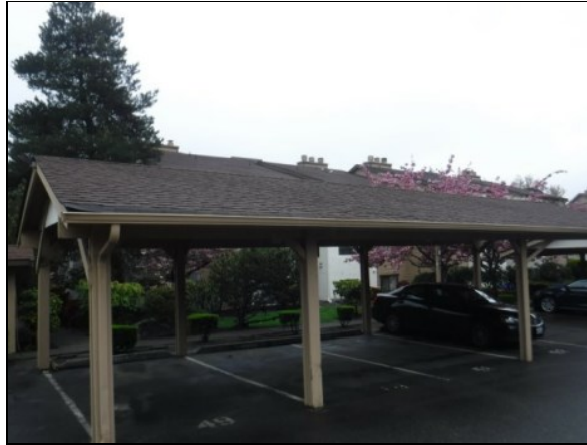
Comments: Generally fair condition with no excessive moss or observable damage. Anticipate replacement of 2005 carport roofs at timeline below.

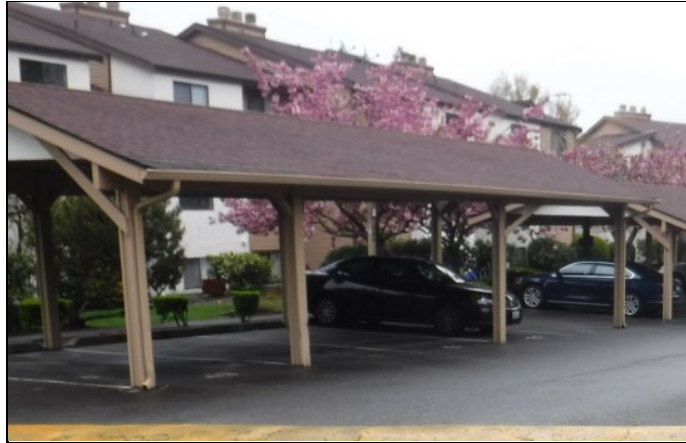
Comments: Fair condition. No excessive moss buildup or observable damage. Carport roofs last replaced in 2008 are factored below.

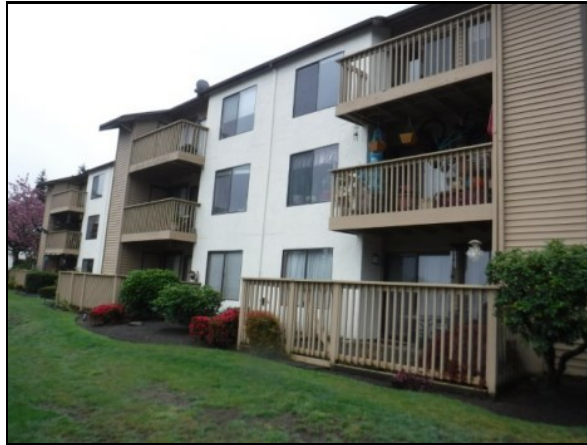
Comments: This component represents Phase 2 of 3 and includes Buildings 1, 2 and Carports. For full painting details see component #532 above.

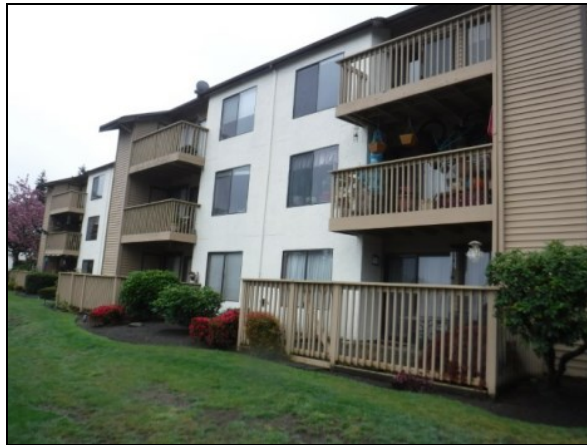
Comments: This component represents Phase 3 of 3 and includes Building 3 and includes mailbox kiosks, lamp posts, bridge, storage sheds, garbage enclosures. For full painting details see component #532 above.
