Lakeside Village Condominiums

Lakeside Village
Federal Way, WA

RESERVE STUDY

Update "With-Site-Visit"

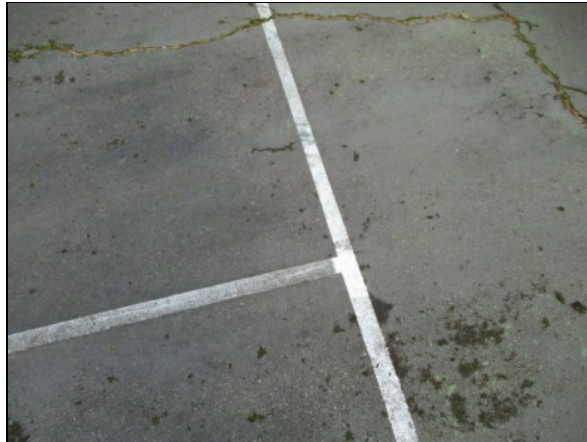
Comments: The asphalt tennis court surface has significant cracking, surface wear, and organic growth. Based on observed levels of current damage, expect the need for complete resurfacing to restore the functionality of this asset. Adjust as future conditions dictate.

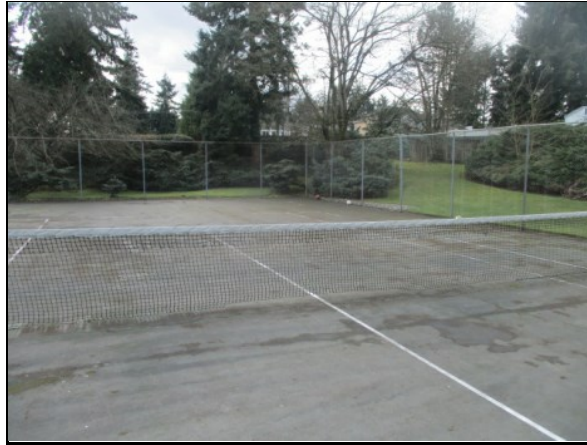
Comp #: 323 Tennis Court Fence - Replace**Quantity: ~360 LF chain link**

Comments: The fence has some surface rust, but otherwise no instability. Sturdy component that can last for extended period of time if not damaged or abused. Clean, treat for corrosion and repair when needed as general maintenance from the Operating budget. Community may remove court - we have deferred until the next With Site Visit reserve study update, to allow time to investigate options further.

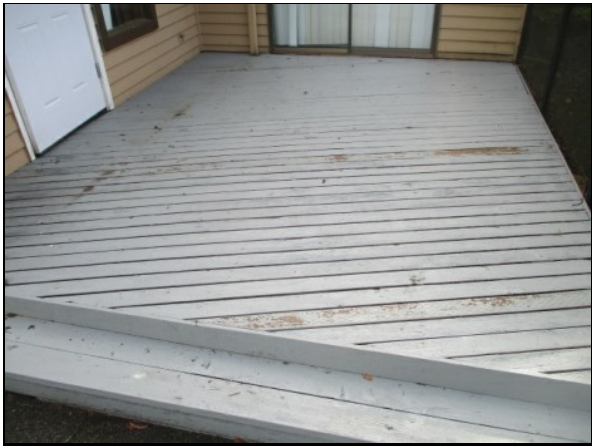
Comp #: 425 Cabana Deck - Repair/Replace

Comments: Structurally intact, but noted moderate surface wear. We recommend regular cleaning and application of stain/paint for protection, renewed appearance and maximum design life. Select appropriate traffic coating product specifically for wood decks.

Plan for significant repair/replacement at the approximate time frame noted below.

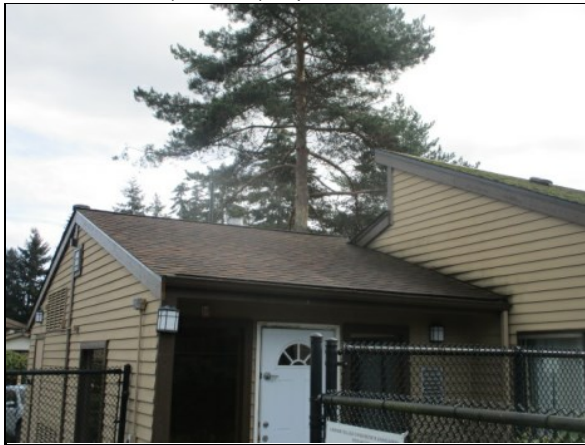
Comp #: 428 Cabana Roof - Repair/Replace**Quantity: ~ 2,600 SF composition**

Comments: The cabana roof was intact and without significant degradation but widespread organic growth on the northern slope of the roof.

Ventilation, the lack of which can greatly reduce the roof's useful life, was provided by roof jacks. Visible portions of roof flashing were observed at the rake, headwall, and sidewall conditions. Gutters blocked the view of eaves, so eave flashing was not confirmed. Organic debris was observed on the roof surface. A Reserve study conducts only a limited visual review, and many of the critical waterproofing and ventilation items of the roof are not readily viewable. For a full evaluation have a professional roof consultant/contractor perform a thorough up-close survey of your entire roof system, including attic inspection (if any).

As routine maintenance, most manufacturers recommend inspections at least twice annually (once in the fall before the rainy season and again in the spring) and after large storm events. Promptly replace any damaged/missing sections or any other repair needed to ensure waterproof integrity of roof. Keep roof surface, gutters, and downspouts clear and free of moss or debris.

At the time of re-roofing, we recommend that you hire a professional consultant to evaluate the existing roof and specify the new roof materials/design, provide installation oversight. We recommend that all Associations hire qualified consultants whenever they are considering having work performed on any building envelope (waterproofing) components including; roof, walls, windows, decks, exterior painting, and caulking/sealant.

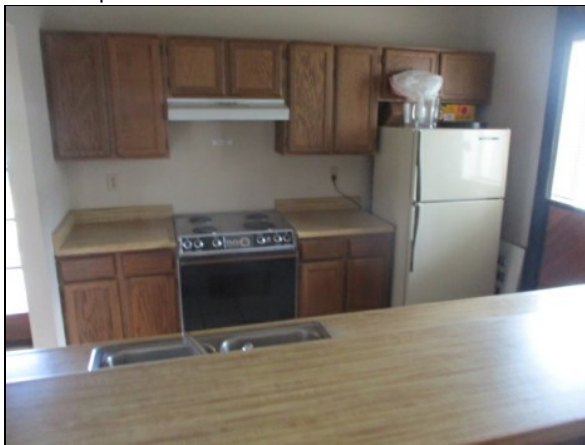
Comments: Smaller kitchen with older fixtures. It is our understanding that individual replacements of appliances and/or cabinetry will take place on an as-needed basis and will be funded from the Operating budget.

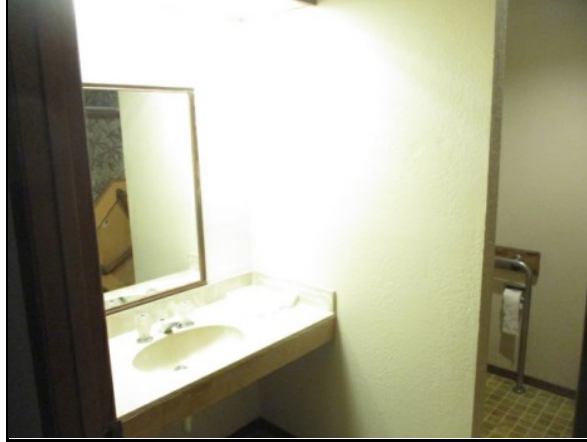
Comments: Both bathrooms are simple two-piece facilities without showers. We assume ongoing individual replacement of items such as fixtures, vanities, lighting, etc. will be handled when needed as general maintenance from the Operating budget.

Our recommendations are to include replacement of bathroom flooring and painting projects along with other interior surfaces, not as separate events.

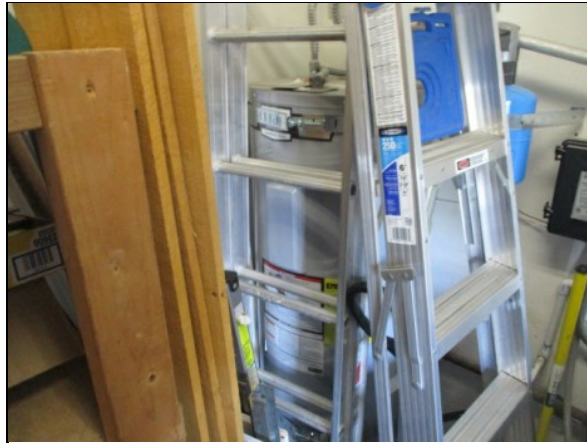
Comp #: 475 Cabana Water Heater - Replace

Comments: Proactive replacement at approximately every 10 years is recommended. Cost is projected too small to merit separate reserve funding. Replace as general maintenance from the Operating budget.

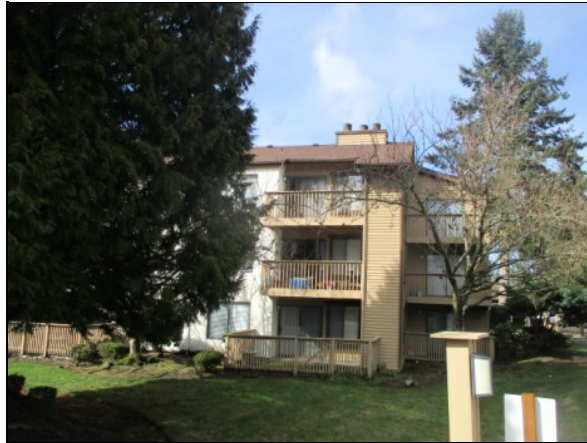
Comp #: 500 Roofs: Bldgs 1-4 - Repair/Replace

Comments: The roofing was noted to be intact, with no signs of missing shingles or major warping. No reports of leaks or other issues were provided. Based on the age of the roofing, anticipate the need to replace in the near future.

Ventilation, the lack of which can greatly reduce the roof's useful life, was provided by roof jacks. Visible portions of roof flashing were observed at the rake, headwall, and sidewall conditions. Gutters blocked the view of eaves, so eave flashing was not confirmed. Debris and moss was observed on the roof surface. A Reserve study conducts only a limited visual review, and many of the critical waterproofing and ventilation items of the roof are not readily viewable. For a full evaluation have a professional roof consultant/contractor perform a thorough up-close survey of your entire roof system, including attic inspection (if any).
