## Update "With-Site-Visit" Reserve Study

### Lakeside Village Federal Way, WA

**Report #: 13297-8**  
**For Period Beginning: January 1, 2018**  
**Expires: December 31, 2018**

**Date Prepared: February 28, 2017**

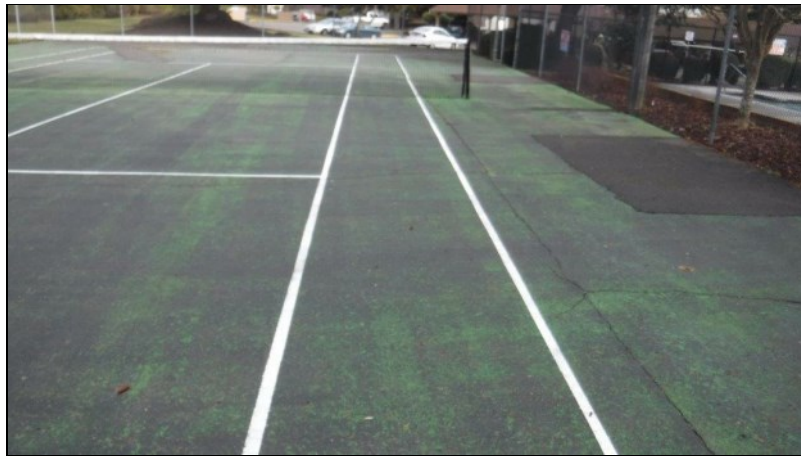
**Comp #: 440 Tennis Court - Seal/Repair****Quantity: ~ 7,200 GSF asphalt**

Funded?: No. Seal/stripe not recommended until overlay project completed

Evaluation: Manager reports vendors do not recommend seal/paint until comprehensive resurfacing/overlay has occurred. Once resurface project takes place, plan for timely intervals of cleaning, minor repair and top coating to maintain a quality playing surface and appearance going forward.

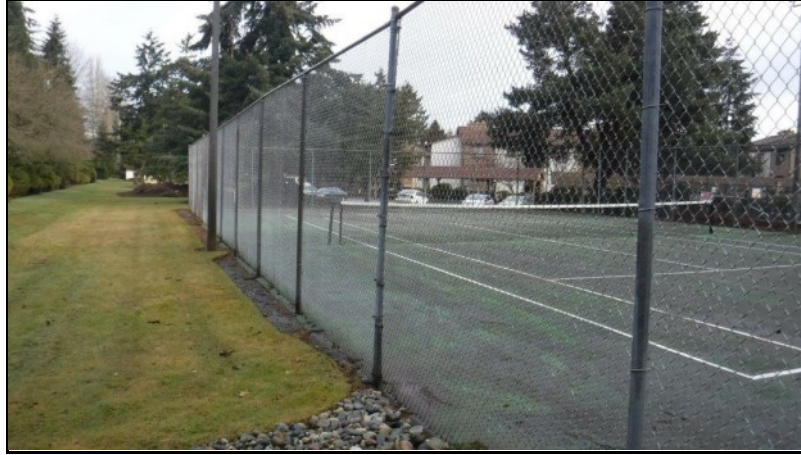
**Comp #: 444 Tennis Court Fence - Replace**

Evaluation: Some surface corrosion but no significant instability noted. Sturdy component that can last for extended period of time if not damaged or abused. Clean, treat for corrosion and repair as needed from operating funds. Best to plan for eventual replacement at the time frame indicated below.

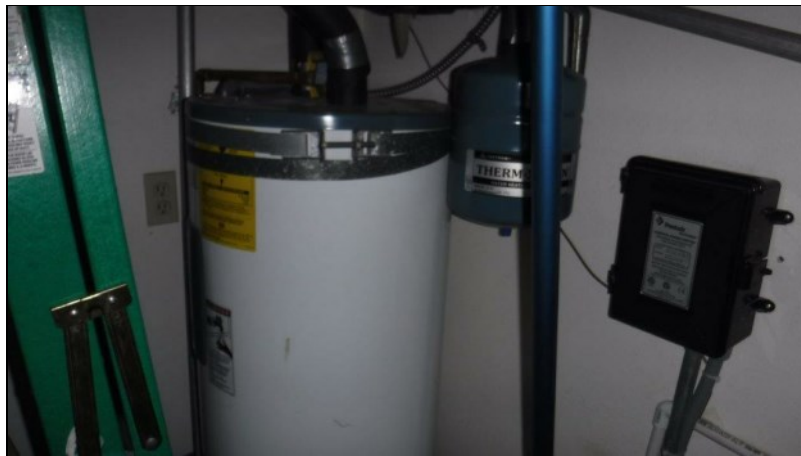
**Comp #: 446 Cabana Water Heater - Replace**

History: Replaced 2007

Evaluation: Too small an expense to merit reserve designation; proactive replacement from operating funds is recommended (~10 year useful life).

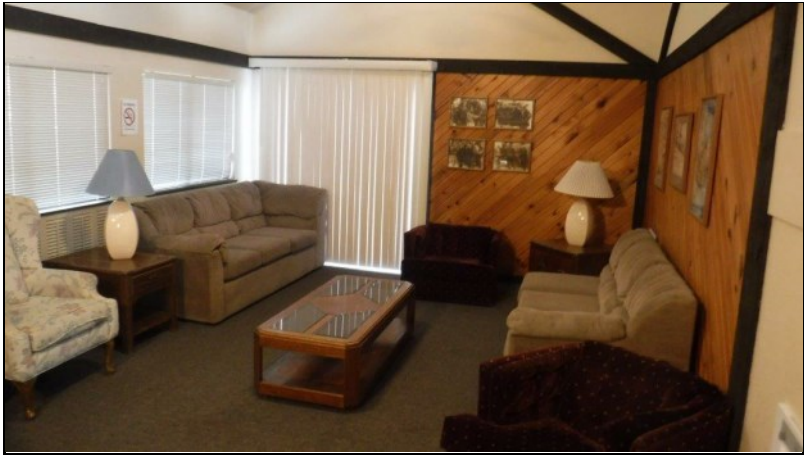
Evaluation: Furnishings largely appear to have been donated over the years. No anticipation of large scale remodeling or expenses to replace furnishings, décor, window treatments, etc.... We assume community standards will continue to be met utilizing maintenance funds and/or donated items for the foreseeable future. No reserve funding is factored.

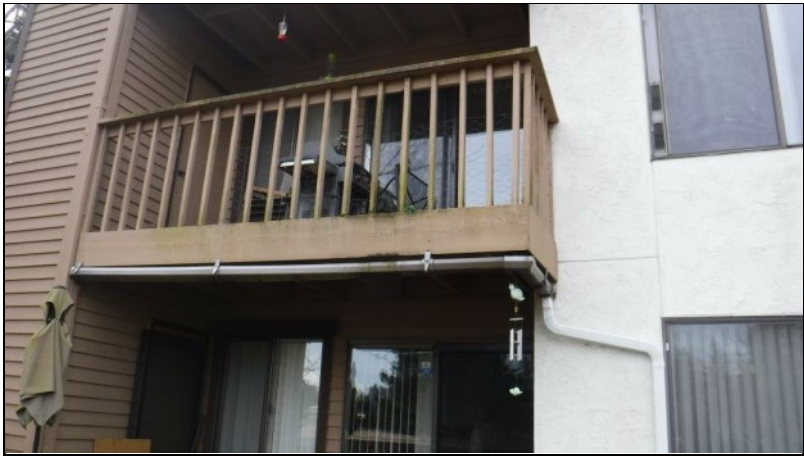
Comp #: 500 Elastomeric Decks - Seal/Repair Quantity: ~ 560 GSF elastomeric

History: Planned for 2017 per Board approved budget; Last repaired and seal coated in 2008, utilizing a Pacific Polymers product.

Evaluation: We were unable to physically access elastomeric decks at this time. Previous inspection (2015) noted deterioration, grime and fading at the one deck of this type that we walked upon. These few decks utilize liquid applied traffic coating and were reported last repaired and seal coated in 2008, utilizing a Pacific Polymers product. It is important to provide for maintenance top coating periodically for waterproof integrity, protection of surrounding structure, maintenance of any warranty and a uniform quality appearance. Although coating may appear intact, surface will lose mil thickness each year and even imperceptible holes can lead to water intrusion and damage. As routine maintenance, we recommend annual professional inspections, with cleaning and repair as needed. Clean with mild solution such as TSP; bleach can be added if mold / mildew become a problem. Going forward, plan for regular intervals of professional maintenance top coating at every four-five year interval.

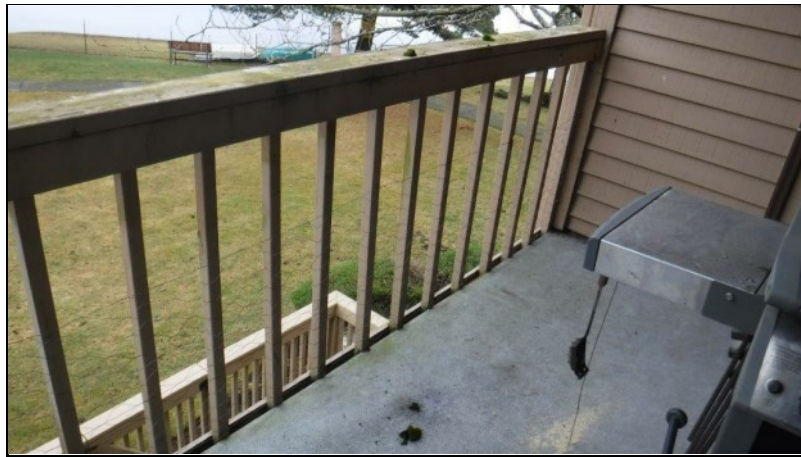
**Comp #: 502 Vinyl Decks - Repair/Resurface (a)****Quantity: ~ 490 GSF vinyl**

Evaluation: The Association has (62) decks that utilize vinyl membranes for traffic surfaces. No problems with lifting or seam separation at the few decks we observed.

Phased projects had occurred since 2006 to significantly repair deck structure, resurface and replace rails on a priority basis and were previously thought to be completed. Our 2014 site inspection confirmed significant structural damage and repair needs at one deck (Unit 434) that had already been repaired once before during previous projects. Current assumption is to provide repair from operating funds for this one deck. No reported comprehensive inspection of all decks in recent years, we strongly recommend third party evaluation to confirm if previous repairs were properly executed; update in future reserve study as conditions merit.

Vinyl traffic and water proofing material can typically last for extended period with ordinary care and maintenance. Take care when moving patio furniture, barbecuing, etc... not to gouge or damage. Annual professional inspections are strongly suggested to ensure waterproof integrity, proper adhesion of surface and drainage. Clean as needed with mild solution to prevent mildew. In our experience, covering will eventually fade and wear over time, necessitating regular intervals of replacement at roughly the 15-20 year time frame below. Pending further expert evaluation, we assume this time frame will be achieved for now. First of six phases, represents future cycles of deck resurfacing and minor repair at those decks completed last in 2006 (122, 124, 126, 132, 134, 136, 326). Note; photo is representative and not necessarily indicative of phasing.

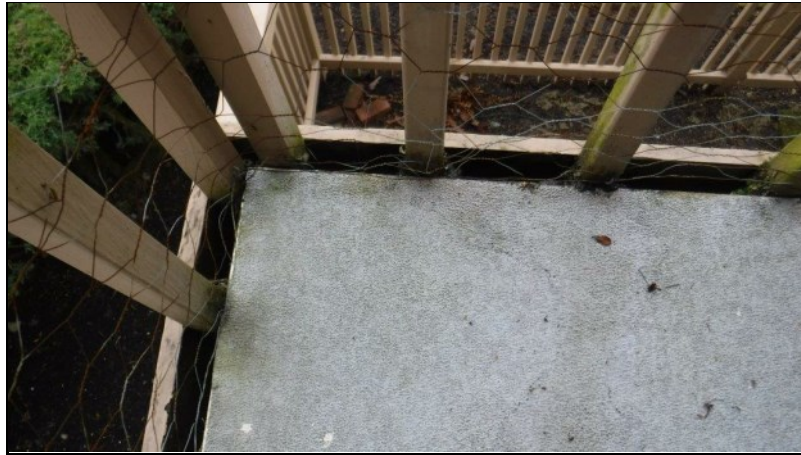
**Comp #: 502 Vinyl Decks - Repair/Resurface (b)****Quantity: ~ 630 GSF vinyl**

Evaluation: Second of six phases, represents future cycles of deck resurfacing and minor repair at those decks completed last in 2007 (135, 222, 331, 422, 431, 432, 434). The reader should note that (18) units have two decks instead of one deck. Note; photo is representative and not necessarily indicative of phasing.

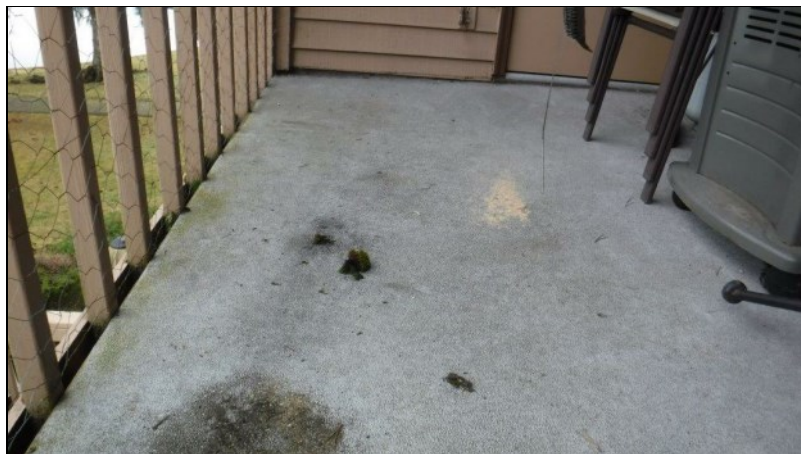
**Comp #: 502 Vinyl Decks - Repair/Resurface (c)****Quantity: ~ 630 GSF vinyl**

Evaluation: Third of six phases, represents future cycles of deck resurfacing and minor repair at those decks completed last in 2008 (123, 133, 223, 233, 234, 321, 521, 531). If proactively inspected and maintained we assume that more significant repairs / replacements such as occurred in recent years (\$3,000-\$5,000 per deck) will not be required again for the foreseeable future. Note; photo is representative and not necessarily indicative of phasing.

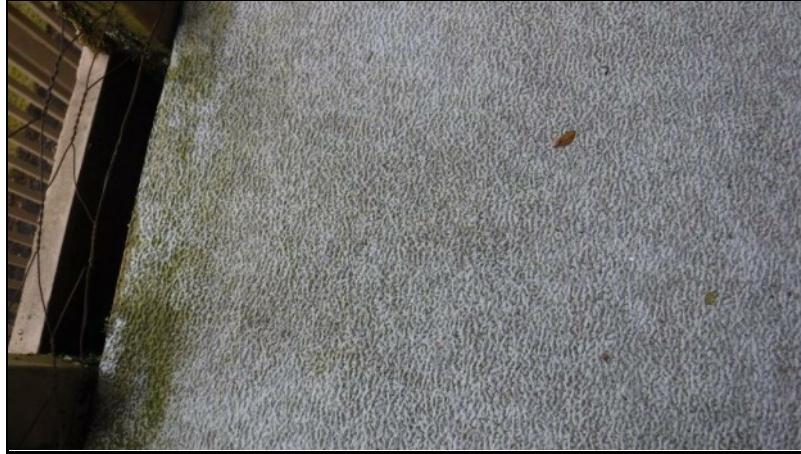
**Comp #: 502 Vinyl Decks - Repair/Resurface (d)****Quantity: ~ 910 GSF vinyl**

Evaluation: Fourth of six phases, represents future cycles of deck resurfacing and minor repair at those decks completed last in 2009 (121, 125, 126, 131, 221, 224, 231, 234, 526). Note; photo is representative and not necessarily indicative of phasing.

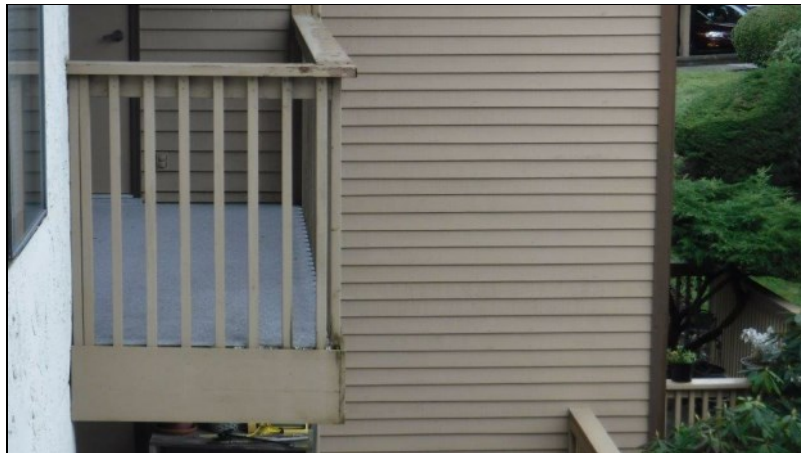
**Comp #: 502 Vinyl Decks - Repair/Resurface (e)****Quantity: ~ 700 GSF vinyl**

Evaluation: Fifth of six phases, represents future cycles of deck resurfacing and minor repair at those decks completed last in 2010 (136, 224, 232, 321, 326, 336, 421, 423, 433). Note; photo is representative and not necessarily indicative of phasing.
