Client: 13297A Lakeside Village

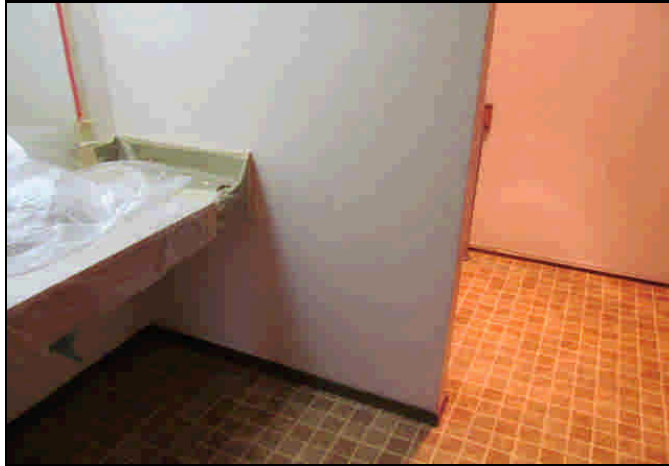
Evaluation: Both bathrooms are simple two-piece facilities without showers. We assume ongoing individual replacement of items such as of fixtures, vanities, lighting, etc.. from annual operating budget will suffice to maintain. Our recommendations are to include replacement of bathroom flooring and painting projects along with other interior surfaces, not as separate events.

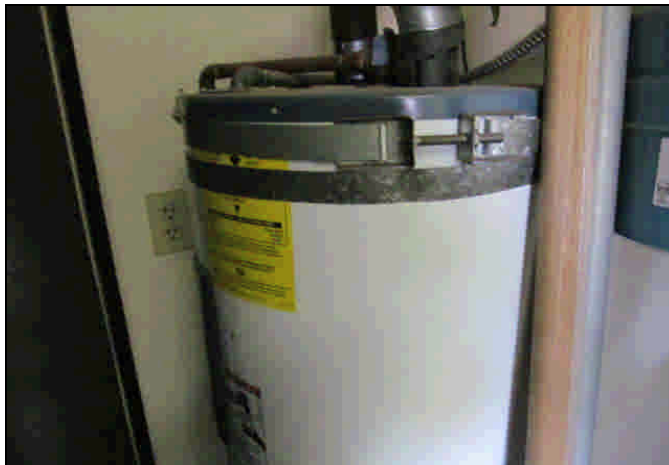
Evaluation: Replaces last in 2007. Too small an expense to merit reserve designation; proactive replacement from operating funds is recommended (~10 year useful life).
