Update “With Site-Visit” Reserve Study

Lakeside Village Federal Way, WA

Report #: 13297-5
For Period Beginning: February 1, 2015
Expires: December 31, 2015
Date Prepared: January 24, 2015

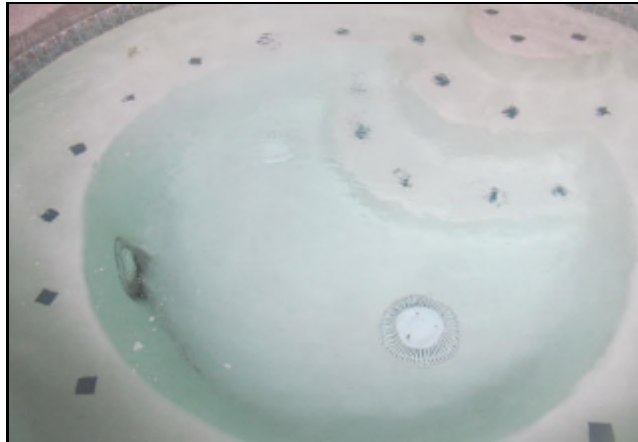
History : Code compliance and repairs at a one-time project expense of \$18,000 were completed in 2014

Evaluation : Code compliance and repairs at a one-time project expense of \$18,000 were completed in 2014. This component represents future intervals of regular plaster resurfacing and tile work. Expect to schedule more frequently compared to pool due to chemical concentrations and higher heat.

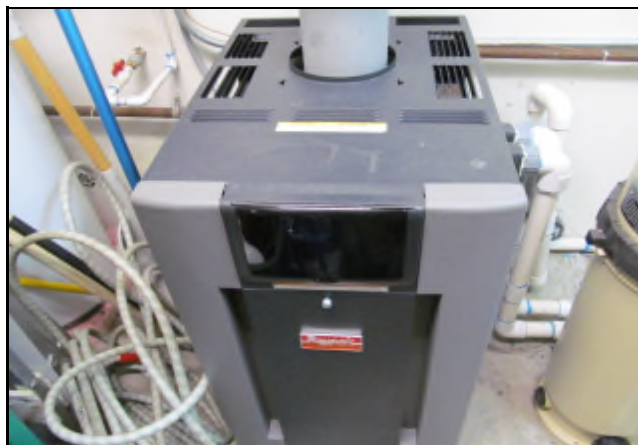
Comp # : 424 Spa Heater - Replace

History : Replaced last in 2014

Evaluation : New 200,000 BTU input unit, replaced last in 2014. Segregated cost was not provided. Plan for regular intervals of replacement at roughly the time frame listed below.

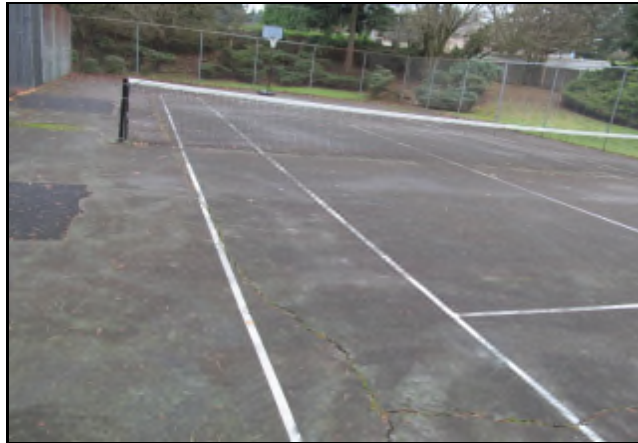
Evaluation : Poor condition of asphalt surface with general deterioration and wear observed. Poorly executed spot repairs in recent years have not improved conditions for serious tennis players. No preliminary bids or plans for renovation to occur in 2015; project is long overdue in our opinion. For purposes of long term planning, large scale resurfacing (overlay) project to maintain this community amenity should be anticipated at the interval indicated below.

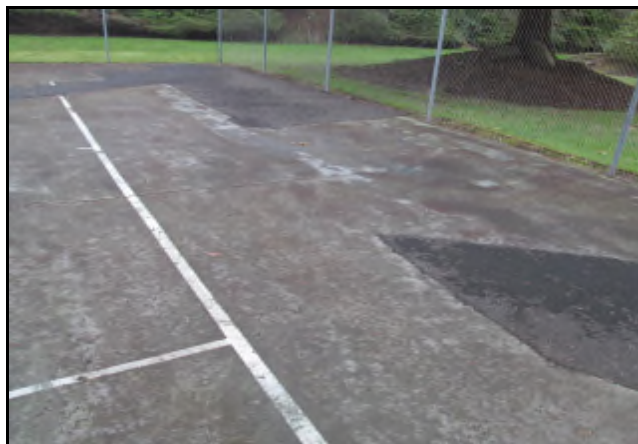
Comp # : 440 Tennis Court - Seal/Repair

Evaluation : Once resurface project takes place, plan for timely intervals of cleaning, minor repair and top coating to maintain a quality playing surface and appearance going forward.

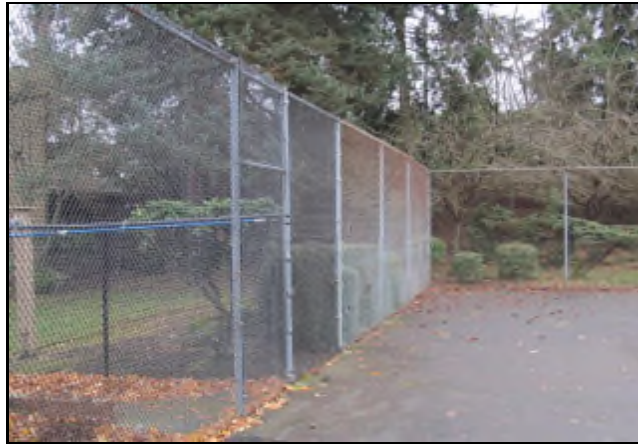
Comp # : 444 Tennis Court Fence - Replace

Evaluation : Some surface corrosion but no significant instability noted. Sturdy component that can last for extended period of time if not damaged or abused. Clean, treat for corrosion and repair as needed from operating funds. Best to plan for eventual replacement at the time frame indicated below.

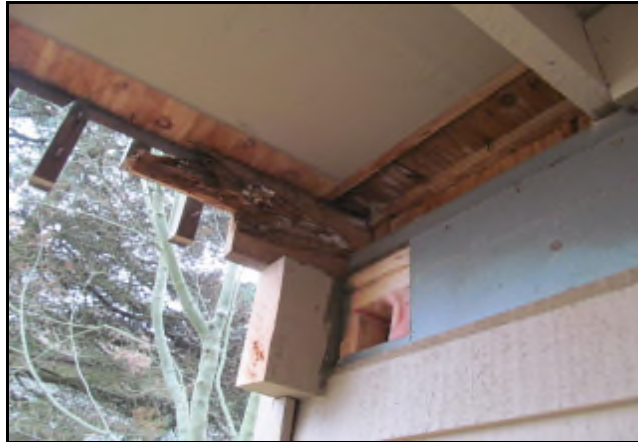
Comp # : 502 Vinyl Decks - Repair/Resurface (a)

Evaluation : The Association apparently has (62) decks that utilize vinyl membranes for traffic surfaces. No problems with lifting or seam separation at the few decks we observed. Phased projects had occurred since 2006 to significantly repair deck structure, resurface and replace rails on a priority basis and were previously thought to be completed. Our 12.4.2014 site inspection confirmed significant structural damage and repair needs at least at one deck (Unit 434) that had already been repaired once before during previous projects. Current assumption is to provide repair from operating funds for this one deck. No comprehensive inspection of all decks in recent years, we strongly recommend third party evaluation to confirm if previous repairs were properly executed; update in future reserve study as conditions merit. Vinyl traffic and water proofing material can typically last for extended period with ordinary care and maintenance. Take care when moving patio furniture, barbecuing, etc... not to gouge or damage. Annual professional inspections are strongly suggested to ensure waterproof integrity, proper adhesion of surface and drainage. Clean as needed with mild solution to prevent mildew. In our experience, covering will eventually fade and wear over time, necessitating regular intervals of replacement at roughly the 15-20 year time frame below. Pending further expert evaluation, we assume this time frame will be achieved for now. First of six phases, represents future cycles of deck resurfacing and minor repair at those decks completed last in 2006 (122, 124, 126, 132, 134, 136, 326). Note; photo is representative and not necessarily indicative of phasing.

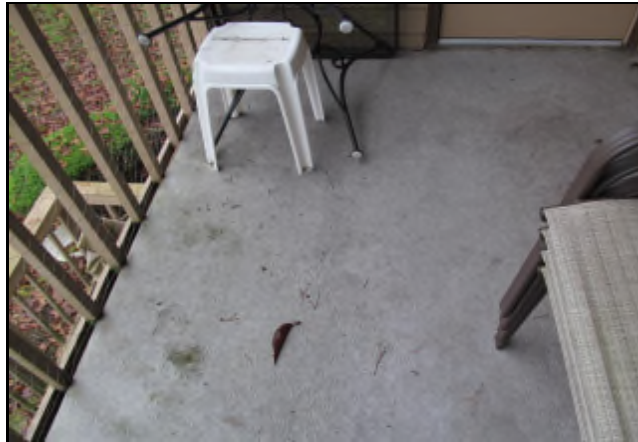
Comp # : 502 Vinyl Decks - Repair/Resurface (b)

Evaluation : Second of six phases, represents future cycles of deck resurfacing and minor repair at those decks completed last in 2007 (135, 222, 331, 422, 431, 432, 434). The reader should note that (18) units have two decks instead of one deck. Note; photo is representative and not necessarily indicative of phasing.

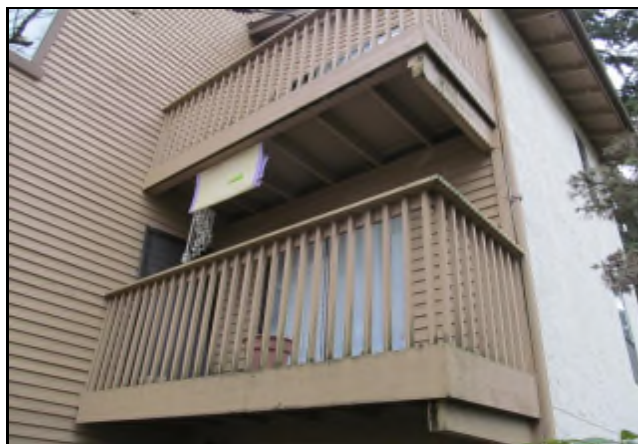
Comp # : 502 Vinyl Decks - Repair/Resurface (c)

Evaluation : Third of six phases, represents future cycles of deck resurfacing and minor repair at those decks completed last in 2008 (123, 133, 223, 233, 234, 321, 521, 531). If proactively inspected and maintained we assume that more significant repairs / replacements such as occurred in recent years (\$3,000-\$5,000 per deck) will not be required again for the foreseeable future. Note; photo is representative and not necessarily indicative of phasing.

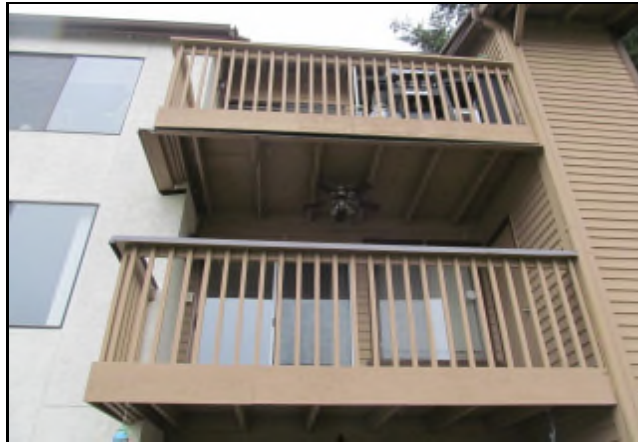
Comp # : 502 Vinyl Decks - Repair/Resurface (d)

Evaluation : Fourth of six phases, represents future cycles of deck resurfacing and minor repair at those decks completed last in 2009 (121, 125, 126, 131, 221, 224, 231, 234, 526). Note; photo is representative and not necessarily indicative of phasing.
