## Update "With-Site-Visit" Reserve Study

### Lakeside Village Federal Way, WA

**Report #: 13297-11**  
**For Period Beginning: January 1, 2021**  
**Expires: December 31, 2021**

**Date Prepared: April 30, 2020**

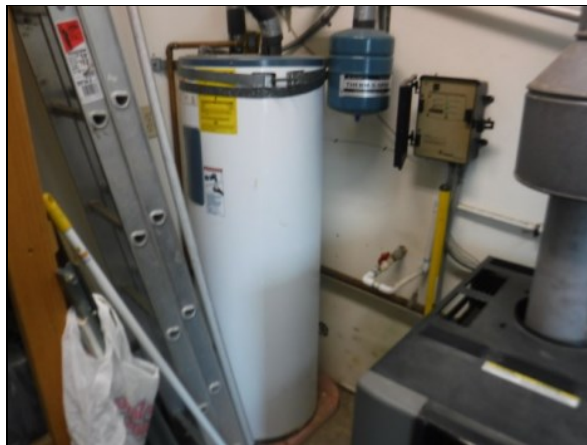
**Comp #: 475 Cabana Water Heater - Replace**

History: Replaced 2007

Comments: Water heater is currently 14 years old. Proactive replacement at approximately every 10 years is recommended. Cost is projected too small to merit separate reserve funding. Replace as general maintenance from the Operating budget.

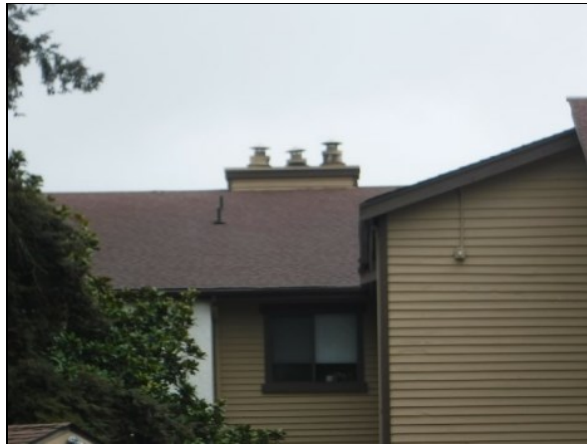
### Comp #: 500 Roofs: Bldgs 1-4 - Repair/Replace

History: Replaced 2003

Comments: Generally fair condition of field observed during our limited visual review from ground level. Ventilation, the lack of which can greatly reduce the roof's useful life, was provided by roof jacks. Visible portions of roof flashing were observed at the rake, headwall, and sidewall conditions. Gutters blocked the view of eaves, so eave flashing was not confirmed. Debris and moss was observed on the roof surface. A Reserve study conducts only a limited visual review, and many of the critical waterproofing and ventilation items of the roof are not readily viewable. For a full evaluation have a professional roof consultant/contractor perform a thorough up-close survey of your entire roof system, including attic inspection (if any).

Useful Life:  
25 years

Remaining Life:  
7 years

As routine maintenance, many manufacturers recommend inspections at least twice annually (once in the fall before the rainy season and again in the spring) and after large storm events. Promptly replace any damaged/missing sections or any other repair needed to ensure waterproof integrity of roof. Keep roof surface, gutters, and downspouts clear and free of moss or debris.

At the time of re-roofing, we recommend that you hire a professional consultant to evaluate the existing roof and specify the new roof materials/design, provide installation oversight. We recommend that all Associations hire qualified consultants whenever they are considering having work performed on any building envelope (waterproofing) components including; roof, walls, windows, decks, exterior painting, and caulking/sealant.

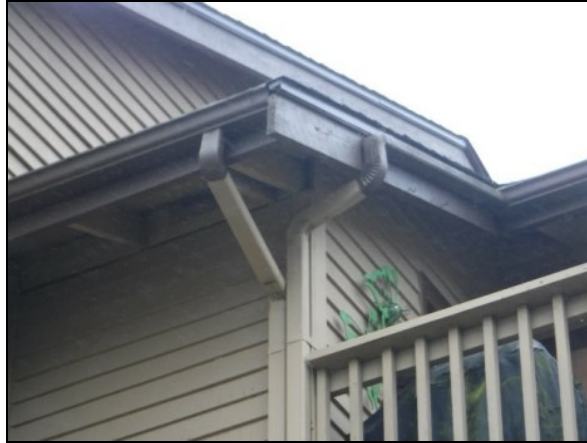
**Comp #: 516 Gutters & Downspouts - Replace**

Comments: No performance problems observed or reported. Age and condition varies; no significant damage or instability observed at this time.

Inspect regularly, keep gutters and downspouts free of debris to ensure water evacuating from rooftops as designed and continue to repair/replace when needed as general maintenance from the Operating budget.

No anticipation of large scale replacements from Reserves under this pattern of care.

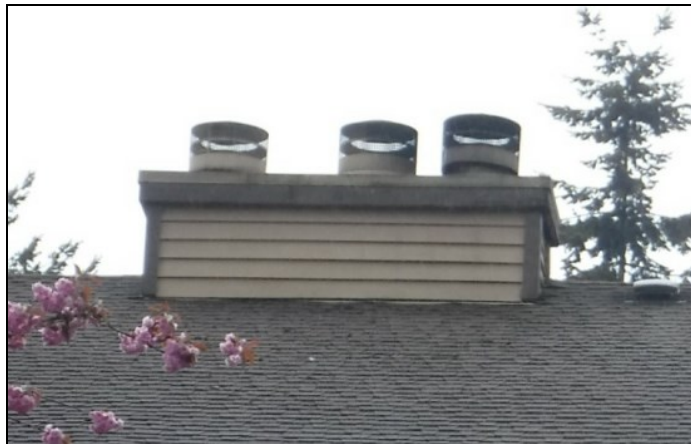
**Comp #: 518 Chimney Covers & Caps - Replace**

Comments: Some replacements in previous years noted in previous study with plans reported to continue replacing any worn metal work as ongoing maintenance from the Operating budget (each cover/cap location at an expense of ~\$1,800 for stainless steel covers).

Inspect regularly along with all rooftop components to ensure water proofing of buildings is maintained and clean/treat with rust inhibitor where appropriate to help extend life. Assuming adequate provisions for timely replacements are funded from the Operating budget we have not factored Reserve funding. Track needs and actual expenses carefully and incorporate funding into future Reserve study updates if warranted.
